Access Compliance Report

Public Rights-of-Way

(Curb Ramps)

Intersection ID: 10029993	Main Street: LANCASTER_HY	Cross Street: N/A	Location: NE
ADA ID: 2C619D240AD6	Ramp Type: Perp	Initial Pass/Fail: Fail	Overall Compliance: No
Severity Score: 13.75			
Codes/Mitigation Info/Possible Solution		Field Measurements/Component Compliance

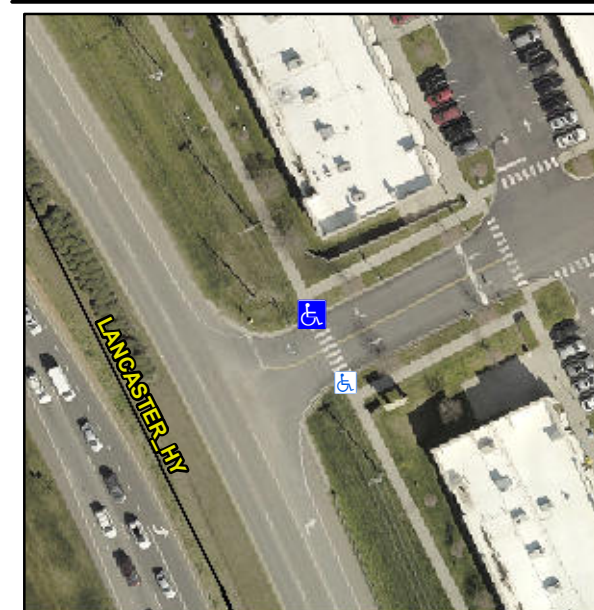
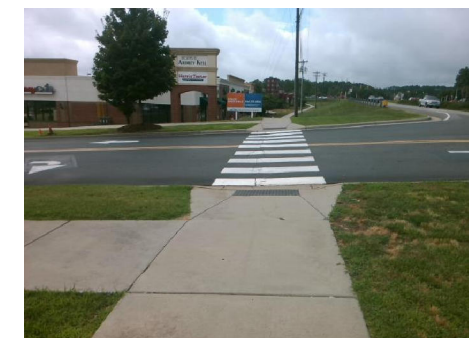
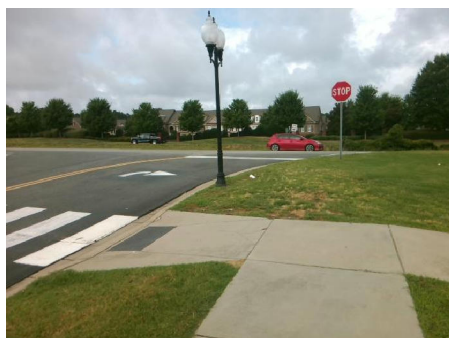
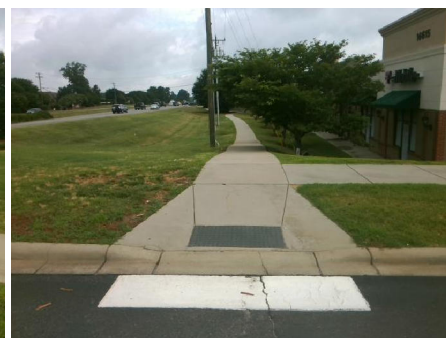
Not Found, R304.2.2, R304.5.3

Compliance	Description	Data	Compliance	Description	Data
N/A	Ramp Length (in)	93.0	No	Ramp Slope (%)	10.2
Yes	Ramp Width (in)	48.0	No	Ramp XSlope (%)	4.6
N/A	Flare Type LT	N/A	N/A	Flare Type RT	N/A
N/A	Flare Slope LT (%)	N/A	N/A	Flare Slope RT (%)	N/A
N/A	Flare Traversable LT?	N/A	N/A	Flare Traversable RT?	N/A
N/A	Landing Length (in)	N/A	N/A	DWS Provided?	N/A
N/A	Landing Width (in)	N/A	N/A	DWS Contrast?	N/A
N/A	Landing Slope (%)	N/A	N/A	DWS Length (in)	N/A
N/A	Landing X Slope (%)	N/A	N/A	DWS Full Width?	N/A
N/A	Landing Curb? (Y/N)	N/A	N/A	DWS Offset (in)	N/A
N/A	Shared Landing?	N/A			
N/A	Gutter Ponding?	N/A	N/A	Gutter Slope (%)	N/A
N/A	Gutter Lip Ht (in)	N/A	N/A	Gutter X Slope (%)	N/A
N/A	Painted X Walk1?	Yes	N/A	Painted X Walk2?	N/A
	X Walk 1 Direction	To S		X Walk 2 Direction	N/A
N/A	X Walk 1 Width (in)	97.0	N/A	X Walk 2 Width (in)	N/A
	X Walk 1 Slope (%)	1.6		X Walk 2 Slope (%)	N/A
	X Walk 1 X Slope (%)	8.6		X Walk 2 X Slope (%)	N/A

N/A	Ramp inside XWalk1?	Yes	N/A	Ramp inside XWalk2?	N/A
	Road Slope (%)	N/A	N/A	Clear Space?	N/A
	Road X Slope (%)	N/A	N/A	Clear Space to XWalk (in)	N/A
N/A	Any Obstructions?	N/A	N/A	Storm Grate/Utility Hazard?	N/A
	Obstruction Type			Storm Grate/Utility Type	
		N/A			N/A
		Yes		Surface Condition? (G/P)	Good

Possible Solutions:

Remove & Replace Entire Ramp.
