Access Compliance Report

Public Rights-of-Way

(Curb Ramps)

Intersection ID: 11254	Main Street: AFTON_LN	Cross Street: CARROWMORE_PL	Location: SW
ADA ID: 2C81E4F32891	Ramp Type: Perp	Initial Pass/Fail: Fail	Overall Compliance: No
Severity Score: 1.25			
Codes/Mitigation Info/Possible Solution		Field Measurements/Component Compliance

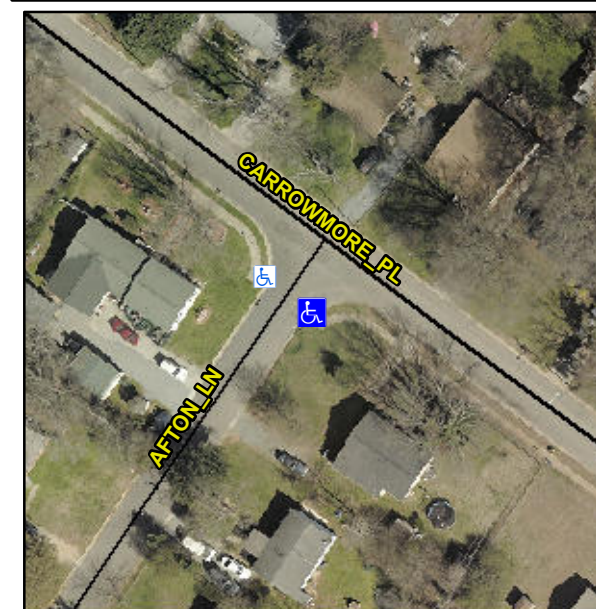
Not Found, R304.5.3

Compliance	Description	Data	Compliance	Description	Data
N/A	Ramp Length (in)	47.5	Yes	Ramp Slope (%)	7.7
Yes	Ramp Width (in)	48.0	No	Ramp XSlope (%)	2.2
N/A	Flare Type LT	N/A	N/A	Flare Type RT	N/A
N/A	Flare Slope LT (%)	N/A	N/A	Flare Slope RT (%)	N/A
N/A	Flare Traversable LT?	N/A	N/A	Flare Traversable RT?	N/A
N/A	Landing Length (in)	N/A	N/A	DWS Provided?	N/A
N/A	Landing Width (in)	N/A	N/A	DWS Contrast?	N/A
N/A	Landing Slope (%)	N/A	N/A	DWS Length (in)	N/A
N/A	Landing X Slope (%)	N/A	N/A	DWS Full Width?	N/A
N/A	Landing Curb? (Y/N)	N/A	N/A	DWS Offset (in)	N/A
N/A	Shared Landing?	N/A			
N/A	Gutter Ponding?	N/A	N/A	Gutter Slope (%)	N/A
N/A	Gutter Lip Ht (in)	N/A	N/A	Gutter X Slope (%)	N/A
N/A	Painted X Walk1?	No	N/A	Painted X Walk2?	N/A
	X Walk 1 Direction	To NW		X Walk 2 Direction	N/A
N/A	X Walk 1 Width (in)	N/A	N/A	X Walk 2 Width (in)	N/A
	X Walk 1 Slope (%)	1.9		X Walk 2 Slope (%)	N/A
	X Walk 1 X Slope (%)	2.7		X Walk 2 X Slope (%)	N/A

Remove & Replace Entire Ramp.
