# Access Compliance Report

## Public Rights-of-Way

### (Curb Ramps)

Intersection ID: 11898	Main Street: ALLEN_ST	Cross Street: E_18TH_ST	Location:	N
ADA ID: 2C82235C9ACD	Ramp Type: BlendTrans1	Initial Pass/Fail: Fail	Overall Compliance: No	Severity Score: 12.5
Codes/Mitigation Info/Possible Solution		Field Measurements/Component Compliance

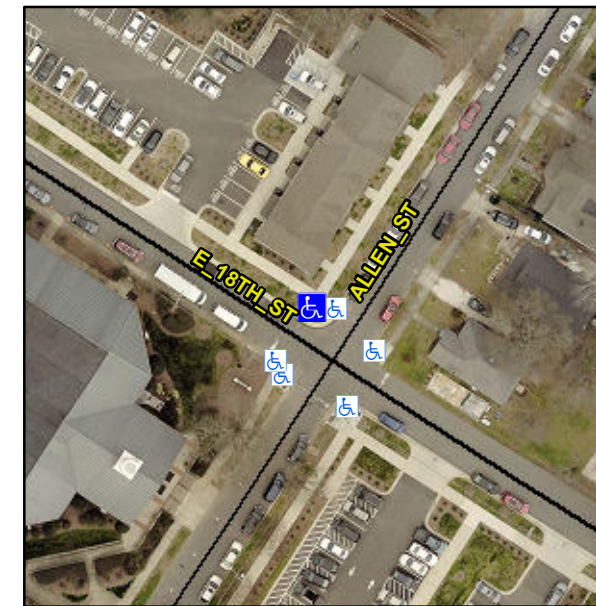
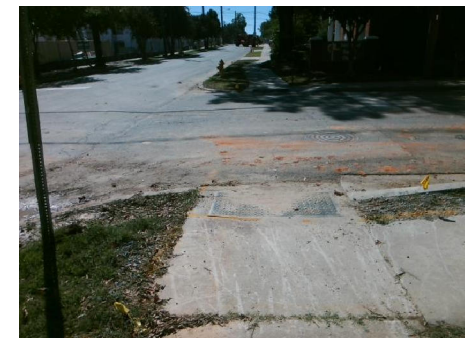
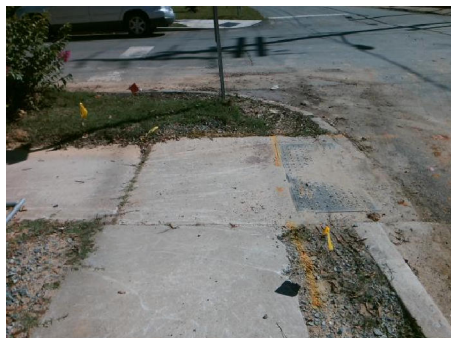
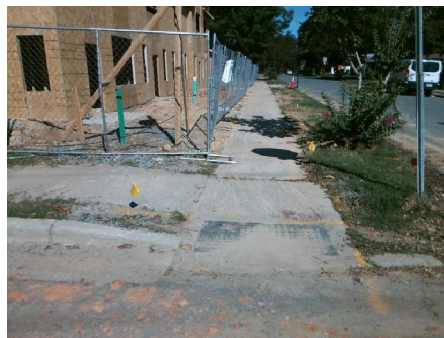
Compliance	Description	Data	Compliance	Description	Data
N/A	Ramp Length (in)	75.0	Yes	BlendTrans Slope (%)	2.2
Yes	Ramp Width (in)	48.0	No	BlendTrans XSlope (%)	6.0
N/A	Flare Type LT	N/A	N/A	Flare Type RT	N/A
N/A	Flare Slope LT (%)	N/A	N/A	Flare Slope RT (%)	N/A
N/A	Flare Traversable LT?	N/A	N/A	Flare Traversable RT?	N/A
N/A	Landing Length (in)	N/A	N/A	DWS Provided?	N/A
N/A	Landing Width (in)	N/A	N/A	DWS Contrast?	N/A
N/A	Landing Slope (%)	N/A	N/A	DWS Length (in)	N/A
N/A	Landing X Slope (%)	N/A	N/A	DWS Full Width?	N/A
N/A	Landing Curb? (Y/N)	N/A	N/A	DWS Offset (in)	N/A
N/A	Shared Landing?	N/A			
N/A	Gutter Ponding?	Yes	N/A	Gutter Slope (%)	N/A
N/A	Gutter Lip Ht (in)	N/A	N/A	Gutter X Slope (%)	N/A
N/A	Painted X Walk1?	No	N/A	Painted X Walk2?	N/A
	X Walk 1 Direction	To SW		X Walk 2 Direction	N/A
	X Walk 1 Width (in)	N/A		X Walk 2 Width (in)	N/A
	X Walk 1 Slope (%)	2.3		X Walk 2 Slope (%)	N/A
	X Walk 1 X Slope (%)	3.7		X Walk 2 X Slope (%)	N/A

N/A	Ramp inside XWalk1?	N/A	N/A	Ramp inside XWalk2?	N/A
	Road Slope (%)	3.7		Clear Space?	N/A
	Road X Slope (%)	2.3	N/A	Clear Space to XWalk (in)	N/A
N/A	Any Obstructions?	N/A	N/A	Storm Grate/Utility Hazard?	N/A
	Obstruction Type			Storm Grate/Utility Type	
		N/A			N/A
			Yes	Surface Condition? (G/P)	Good
			N/A	Curb Slope (%)	2.1

**Remove & Replace Curb Ramp With Two New Directional Ramps or Equivalent.**

**R304.5.3**

**\$ 3200.00**
