Access Compliance Report Public Rights-of-Way (Curb Ramps)

Intersection ID: 48865	Main Street: TIGRESS_CT	Cross Street: ERWIN_RD	Location: NE
ADA ID: 2C861CD51B5F	Ramp Type: PerpDiag	Initial Pass/Fail: Fail	Overall Compliance: No Severity Score: 12.5

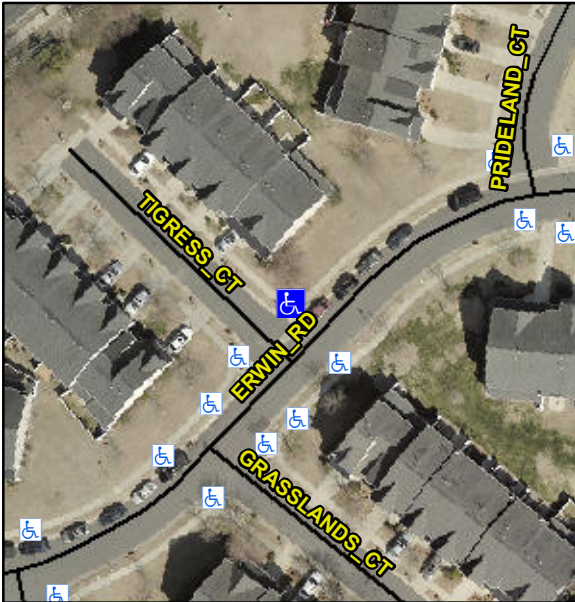
Compliance	Description	Data	Compliance	Description	Data
N/A	Ramp Length (in)	48.0	Yes	Ramp Slope (%)	7.0
Yes	Ramp Width (in)	48.0	No	Ramp XSlope (%)	5.6
N/A	Flare Type LT	N/A	N/A	Flare Type RT	N/A
N/A	Flare Slope LT (%)	N/A	N/A	Flare Slope RT (%)	N/A
N/A	Flare Traversable LT?	N/A	N/A	Flare Traversable RT?	N/A
N/A	Landing Length (in)	N/A	N/A	DWS Provided?	N/A
N/A	Landing Width (in)	N/A	N/A	DWS Contrast?	N/A
N/A	Landing Slope (%)	N/A	N/A	DWS Length (in)	N/A
N/A	Landing X Slope (%)	N/A	N/A	DWS Full Width?	N/A
N/A	Landing Curb? (Y/N)	N/A	N/A	DWS Offset (in)	N/A
N/A	Shared Landing?	N/A			
N/A	Gutter Ponding?	N/A	N/A	Gutter Slope (%)	N/A
N/A	Gutter Lip Ht (in)	N/A	N/A	Gutter X Slope (%)	N/A
N/A	Painted X Walk1?	No	N/A	Painted X Walk2?	No
	X Walk 1 Direction	To SW		X Walk 2 Direction	To SE
N/A	X Walk 1 Width (in)	N/A	N/A	X Walk 2 Width (in)	N/A
	X Walk 1 Slope (%)	0.5		X Walk 2 Slope (%)	2.1
	X Walk 1 X Slope (%)	3.3		X Walk 2 X Slope (%)	2.1

N/A	Ramp inside XWalk1?	N/A	N/A	Ramp inside XWalk2?	N/A
	Road Slope (%)	4.1	N/A	Clear Space?	N/A
	Road X Slope (%)	0.2	N/A	Clear Space to XWalk (in)	N/A
N/A	Any Obstructions?	N/A	N/A	Storm Grate/Utility Hazard?	N/A
	Obstruction Type			Storm Grate/Utility Type	
		N/A			N/A
			Yes	Surface Condition? (G/P)	Good

Possible Solutions:
Remove & Replace Curb Ramp With Two New Directional Ramps or Equivalent.
