Access Compliance Report

Public Rights-of-Way

(Curb Ramps)

| Intersection ID: 17080 | Main Street: MARYLAND_AV | Cross Street: WESTFIELD_RD | Location: SW |

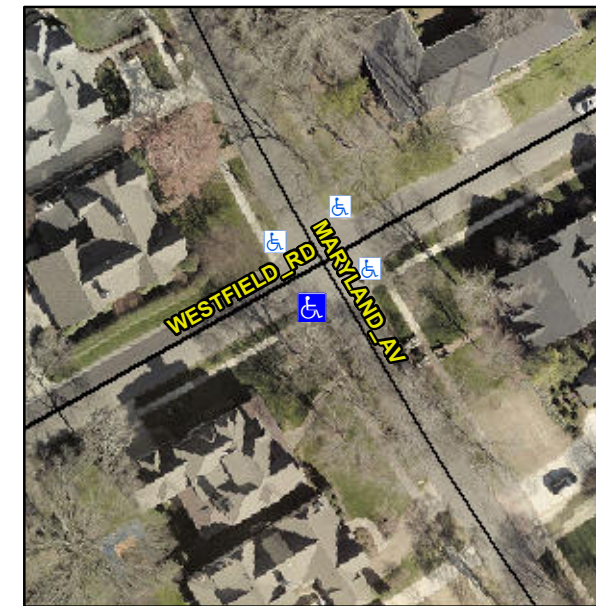
| ADA ID: 2C901718AD26 | Ramp Type: PerpDiag | Initial Pass/Fail: Fail | Overall Compliance: No |
| Severity Score: 8.75 | | | |

R304.5.1

| Compliance | Description | Data | Compliance | Description | Data |
|---|---|---|---|---|---|
| No | Ramp Width (in) | 47.0 | Yes | Ramp XSlope (%) | 0.0 |

Remove & Replace Curb Ramp With Two New Directional Ramps or Equivalent.

Total Cost: \$ 3200.00
