# Access Compliance Report

## Public Rights-of-Way

### (Curb Ramps)

| Intersection ID: 53930 | Main Street: STARNES RANDALL RD | Cross Street: BRITTONDALE LN | Location: NW |

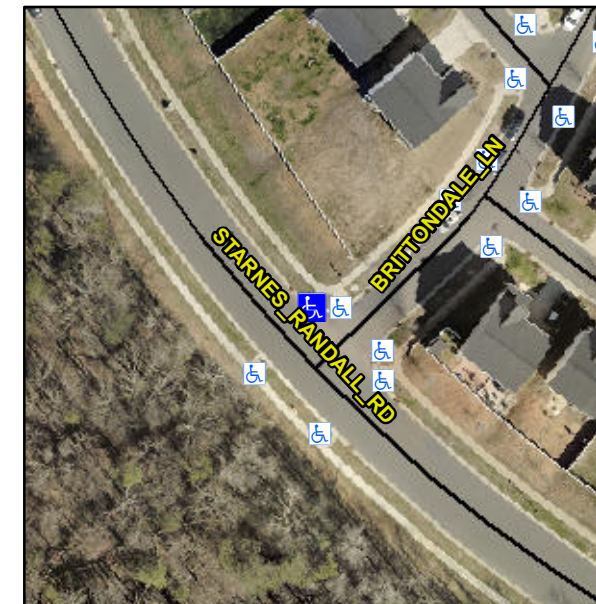
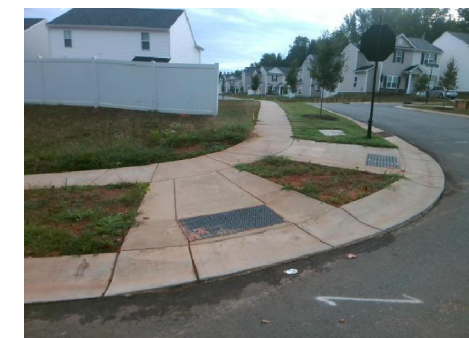
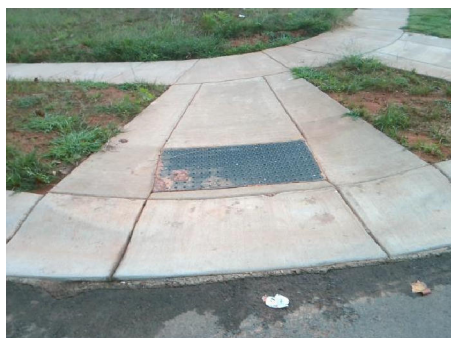
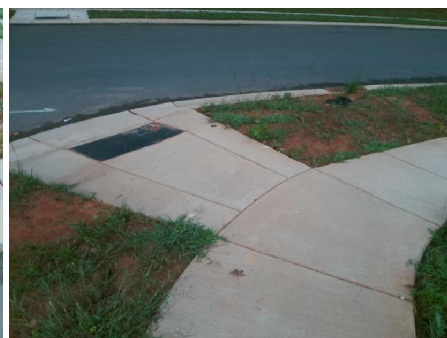
| ADA ID: 2C96018434C0 | Ramp Type: Perp | Initial Pass/Fail: Fail | Overall Compliance: No |

**Not Found, R304.5.1, R304.5.3**

| Compliance | Description | Data | Compliance | Description | Data |
|---|---|---|---|---|---|
| N/A | Ramp Length (in) | 95.0 | Yes | Ramp Slope (%) | 6.7 |
| No | Ramp Width (in) | 29.5 | No | Ramp XSlope (%) | 6.7 |

**Remove & Replace Entire Ramp.**

Total Cost: \$ 1850.00
