Access Compliance Report

Public Rights-of-Way

(Curb Ramps)

Intersection ID: 10025558	Main Street: E_W_T_HARRIS_BV	Cross Street: N/A	Location: NW
ADA ID: 2C96463CC3D6	Ramp Type: Para	Initial Pass/Fail: Fail	Overall Compliance: No
		Severity Score: 12.5

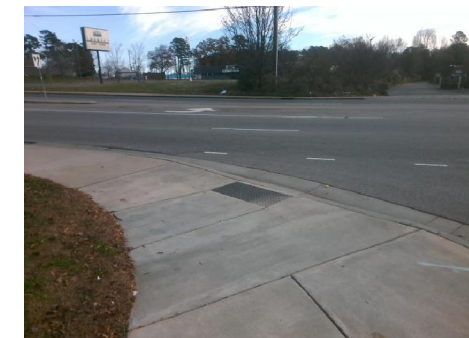
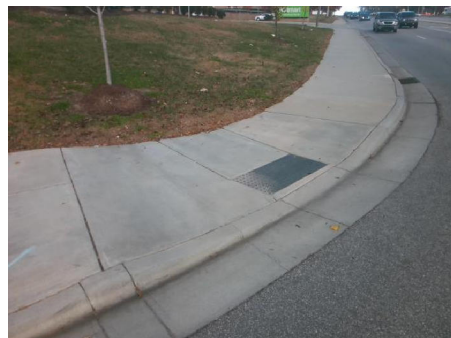
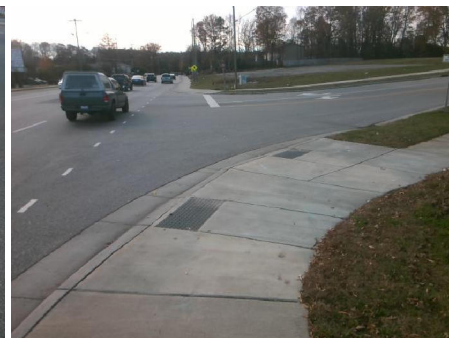
LT RP < 5%

R304.3.2

Compliance	Description	Data	Compliance	Description	Data
N/A	Ramp Length LT (in)	55.0	N/A	Ramp Length RT (in)	48.0
Yes	Ramp Width LT (in)	112.0	Yes	Ramp Width RT (in)	91.0
Yes	Ramp Slope LT (%)	1.6	No	Ramp Slope RT (%)	10.5
Yes	Ramp XSlope LT (%)	0.6	Yes	Ramp XSlope RT (%)	0.6
N/A	Landing Length (in)	N/A	N/A	DWS Provided?	N/A
N/A	Landing Width (in)	N/A	N/A	DWS Contrast?	N/A
N/A	Landing Slope (%)	N/A	N/A	DWS Length (in)	N/A
N/A	Landing X Slope (%)	N/A	N/A	DWS Full Width?	N/A
N/A	Landing Curb? (Y/N)	N/A	N/A	DWS Offset (in)	N/A
N/A	Shared Landing?	N/A			
N/A	Gutter Ponding?	N/A	N/A	Gutter Slope (%)	N/A
N/A	Gutter Lip Ht (in)	N/A	N/A	Gutter X Slope (%)	N/A
N/A	Painted X Walk1?	No	N/A	Painted X Walk2?	N/A
	X Walk 1 Direction	To E		X Walk 2 Direction	N/A
N/A	X Walk 1 Width (in)	N/A	N/A	X Walk 2 Width (in)	N/A
	X Walk 1 Slope (%)	1.9		X Walk 2 Slope (%)	N/A
	X Walk 1 X Slope (%)	3.4		X Walk 2 X Slope (%)	N/A
N/A	Ramp inside XWalk1?	N/A	N/A	Ramp inside XWalk2?	N/A

Road Slope (%)	N/A	N/A	Clear Space?	N/A
	Road X Slope (%)	N/A	N/A	Clear Space to XWalk (in)	N/A
N/A	Any Obstructions?	N/A	N/A	Storm Grate/Utility Hazard?	N/A
	Obstruction Type			Storm Grate/Utility Type	
		N/A			N/A
			Yes	Surface Condition? (G/P)	Good
			N/A	Curb Slope (%)	8.1

Remove & Replace Entire Ramp.
