Access Compliance Report

Public Rights-of-Way

(Curb Ramps)

Intersection ID: 53326	Main Street: FLINT_HILL_DR	Cross Street: CALAWOOD_WY	Location: SE
ADA ID: 2C970FE38EF8	Ramp Type: Perp	Initial Pass/Fail: Pass	Overall Compliance: No
		Severity Score: 15

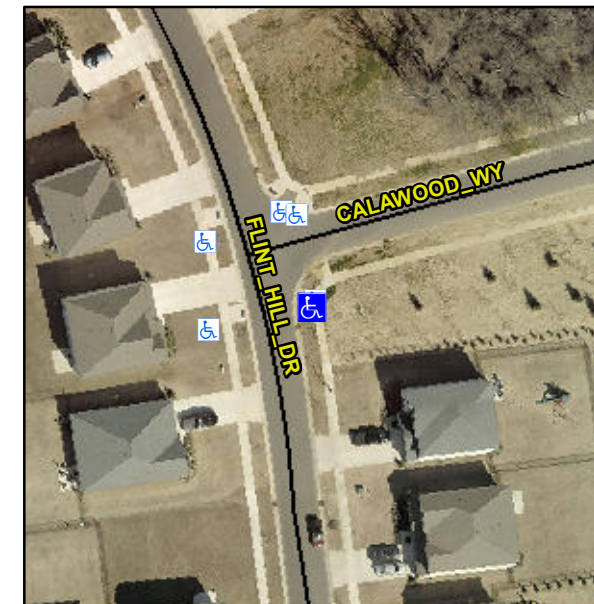
Compliance	Description	Data	Compliance	Description	Data
N/A	Ramp Length (in)	98.0	Yes	Ramp Slope (%)	5.5
Yes	Ramp Width (in)	60.8	Yes	Ramp XSlope (%)	0.4
N/A	Flare Type LT	Sloped	N/A	Flare Type RT	N/A
N/A	Flare Slope LT (%)	4.0	Yes	Flare Slope RT (%)	5.3
N/A	Flare Traversable LT?	Yes	N/A	Flare Traversable RT?	Yes
Yes	Landing Length (in)	58.0	Yes	DWS Provided?	Yes
Yes	Landing Width (in)	60.0	Yes	DWS Contrast?	Yes
Yes	Landing Slope (%)	0.7	Yes	DWS Length (in)	24.0
Yes	Landing X Slope (%)	0.1	Yes	DWS Full Width?	Yes
N/A	Landing Curb? (Y/N)	No	No	DWS Offset (in)	4.0
N/A	Shared Landing?	No			
Yes	Gutter Ponding?	No	Yes	Gutter Slope (%)	1.1
No	Gutter Lip Ht (in)	1.0	Yes	Gutter X Slope (%)	0.6
N/A	Painted X Walk1?	No	N/A	Painted X Walk2?	N/A
	X Walk 1 Direction	To W		X Walk 2 Direction	N/A
N/A	X Walk 1 Width (in)	N/A	N/A	X Walk 2 Width (in)	N/A
	X Walk 1 Slope (%)	3.0		X Walk 2 Slope (%)	N/A
	X Walk 1 X Slope (%)	0.3		X Walk 2 X Slope (%)	N/A

N/A	Ramp inside XWalk1?	N/A	N/A	Ramp inside XWalk2?	N/A
	Road Slope (%)	N/A	N/A	Clear Space?	Yes
	Road X Slope (%)	N/A	N/A	Clear Space to XWalk (in)	N/A
Yes	Any Obstructions?	No	Yes	Storm Grate/Utility Hazard?	No
	Obstruction Type			Storm Grate/Utility Type	
		N/A			N/A
			Yes	Surface Condition? (G/P)	Good

Remove & Replace Detectable Warning System. Grind Gutter Lip.

R305.2, R302.7.2
