# Access Compliance Report

## Public Rights-of-Way

### (Curb Ramps)

Intersection ID: 21239	Main Street: CAMBRIDGE BELTWAY DR	Cross Street: S TRYON ST	Location: SE
ADA ID: 2C9C6C86C021	Ramp Type: Perp	Initial Pass/Fail: Fail	Overall Compliance: No
Severity Score: 13.75			
Codes/Mitigation Info/Possible Solution		Field Measurements/Component Compliance

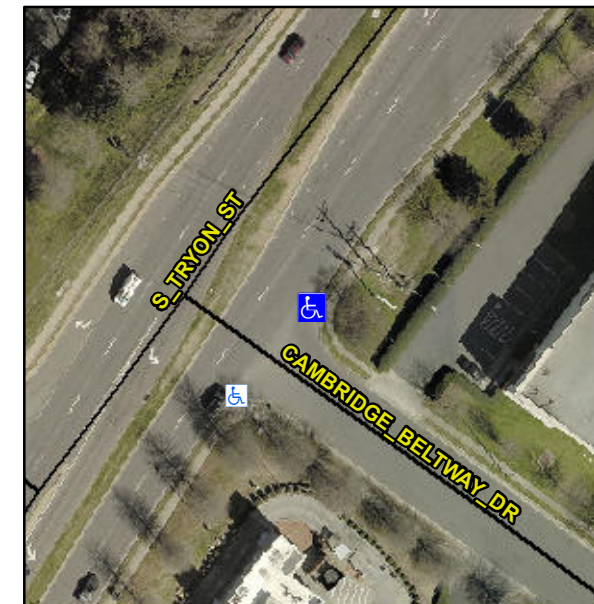
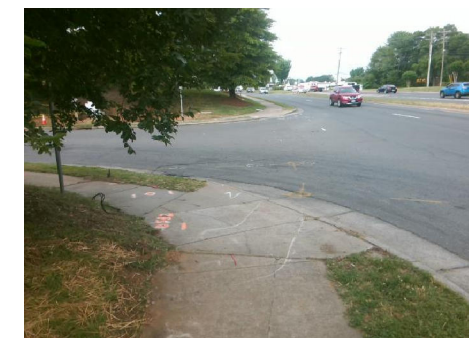
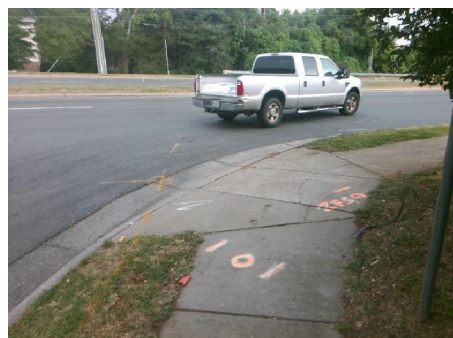
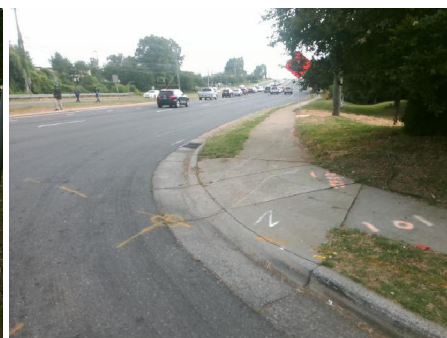
**Not Found, R304.2.2**

Compliance	Description	Data	Compliance	Description	Data
N/A	Ramp Length (in)	90.0	No	Ramp Slope (%)	8.9
Yes	Ramp Width (in)	49.0	Yes	Ramp XSlope (%)	3.0
N/A	Flare Type LT	N/A	N/A	Flare Type RT	N/A
N/A	Flare Slope LT (%)	N/A	N/A	Flare Slope RT (%)	N/A
N/A	Flare Traversable LT?	N/A	N/A	Flare Traversable RT?	N/A
N/A	Landing Length (in)	N/A	N/A	DWS Provided?	N/A
N/A	Landing Width (in)	N/A	N/A	DWS Contrast?	N/A
N/A	Landing Slope (%)	N/A	N/A	DWS Length (in)	N/A
N/A	Landing X Slope (%)	N/A	N/A	DWS Full Width?	N/A
N/A	Landing Curb? (Y/N)	N/A	N/A	DWS Offset (in)	N/A
N/A	Shared Landing?	N/A			
N/A	Gutter Ponding?	N/A	N/A	Gutter Slope (%)	N/A
N/A	Gutter Lip Ht (in)	N/A	N/A	Gutter X Slope (%)	N/A
N/A	Painted X Walk1?	No	N/A	Painted X Walk2?	N/A
	X Walk 1 Direction	To SW		X Walk 2 Direction	N/A
N/A	X Walk 1 Width (in)	N/A	N/A	X Walk 2 Width (in)	N/A
	X Walk 1 Slope (%)	3.0		X Walk 2 Slope (%)	N/A
	X Walk 1 X Slope (%)	6.7		X Walk 2 X Slope (%)	N/A

N/A	Ramp inside XWalk1?	N/A	N/A	Ramp inside XWalk2?	N/A
	Road Slope (%)	N/A	N/A	Clear Space?	N/A
	Road X Slope (%)	N/A	N/A	Clear Space to XWalk (in)	N/A
N/A	Any Obstructions?	N/A	N/A	Storm Grate/Utility Hazard?	N/A
	Obstruction Type			Storm Grate/Utility Type	
		N/A			N/A
			Yes	Surface Condition? (G/P)	Good

Possible Solutions:

**Remove & Replace Entire Ramp.**
