# Access Compliance Report

## Public Rights-of-Way

### (Curb Ramps)

Intersection ID: 6063	Main Street: ALPINE_LN	Cross Street: HOOVER_DR	Location: SE
ADA ID: 2C9CE70D98A3	Ramp Type: Perp	Initial Pass/Fail: Fail	Overall Compliance: No
Severity Score: 21.25			
Codes/Mitigation Info/Possible Solution		Field Measurements/Component Compliance

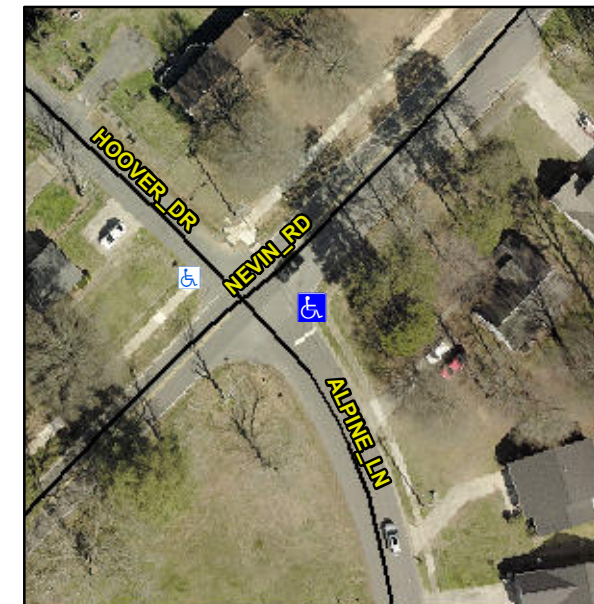
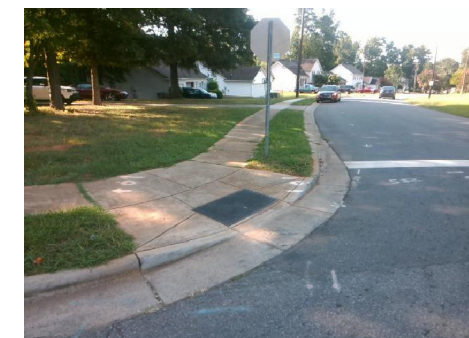
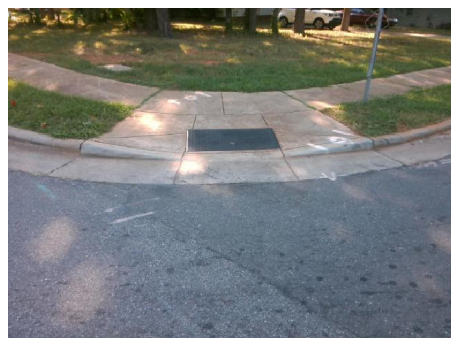
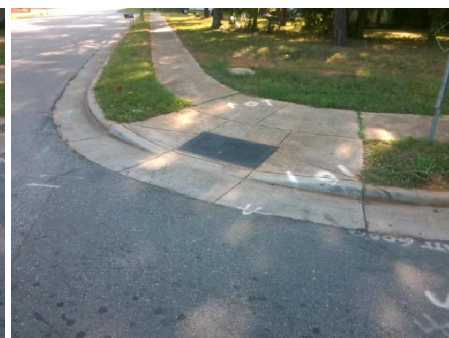
**Not Found, R304.5.1, R304.2.2**

Compliance	Description	Data	Compliance	Description	Data
N/A	Ramp Length (in)	49.0	No	Ramp Slope (%)	10.5
No	Ramp Width (in)	40.0	Yes	Ramp XSlope (%)	1.3
N/A	Flare Type LT	N/A	N/A	Flare Type RT	N/A
N/A	Flare Slope LT (%)	N/A	N/A	Flare Slope RT (%)	N/A
N/A	Flare Traversable LT?	N/A	N/A	Flare Traversable RT?	N/A
N/A	Landing Length (in)	N/A	N/A	DWS Provided?	N/A
N/A	Landing Width (in)	N/A	N/A	DWS Contrast?	N/A
N/A	Landing Slope (%)	N/A	N/A	DWS Length (in)	N/A
N/A	Landing X Slope (%)	N/A	N/A	DWS Full Width?	N/A
N/A	Landing Curb? (Y/N)	N/A	N/A	DWS Offset (in)	N/A
N/A	Shared Landing?	N/A			
N/A	Gutter Ponding?	N/A	N/A	Gutter Slope (%)	N/A
N/A	Gutter Lip Ht (in)	N/A	N/A	Gutter X Slope (%)	N/A
N/A	Painted X Walk1?	No	N/A	Painted X Walk2?	N/A
	X Walk 1 Direction	To NW		X Walk 2 Direction	N/A
N/A	X Walk 1 Width (in)	N/A	N/A	X Walk 2 Width (in)	N/A
	X Walk 1 Slope (%)	7.2		X Walk 2 Slope (%)	N/A
	X Walk 1 X Slope (%)	0.5		X Walk 2 X Slope (%)	N/A

N/A	Ramp inside XWalk1?	N/A	N/A	Ramp inside XWalk2?	N/A
	Road Slope (%)	N/A	N/A	Clear Space?	N/A
	Road X Slope (%)	N/A	N/A	Clear Space to XWalk (in)	N/A
N/A	Any Obstructions?	N/A	N/A	Storm Grate/Utility Hazard?	N/A
	Obstruction Type			Storm Grate/Utility Type	
		N/A			N/A
		Yes		Surface Condition? (G/P)	Good

**Remove & Replace Entire Ramp.**
