Access Compliance Report

Public Rights-of-Way

(Curb Ramps)

Intersection ID: 27121	Main Street: ELM_LN	Cross Street: ENDAHVEN_LN	Location: SW
ADA ID: 2CA10880D5F5	Ramp Type: Para	Initial Pass/Fail: Fail	Overall Compliance: No
		Severity Score: 22.5

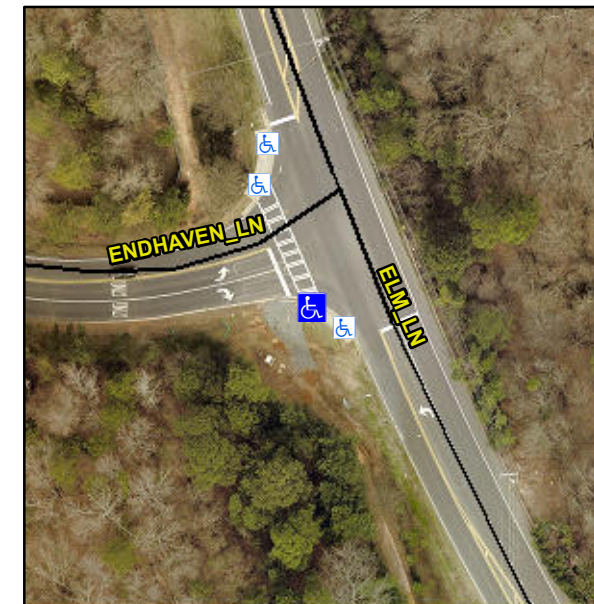
LT RP < 5%

Compliance	Description	Data	Compliance	Description	Data
N/A	Ramp Length LT (in)	67.0	N/A	Ramp Length RT (in)	58.0
No	Ramp Width LT (in)	45.0	No	Ramp Width RT (in)	45.0
Yes	Ramp Slope LT (%)	1.3	No	Ramp Slope RT (%)	11.4
Yes	Ramp XSlope LT (%)	0.9	No	Ramp XSlope RT (%)	2.9
N/A	Landing Length (in)	N/A	N/A	DWS Provided?	N/A
N/A	Landing Width (in)	N/A	N/A	DWS Contrast?	N/A
N/A	Landing Slope (%)	N/A	N/A	DWS Length (in)	N/A
N/A	Landing X Slope (%)	N/A	N/A	DWS Full Width?	N/A
N/A	Landing Curb? (Y/N)	N/A	N/A	DWS Offset (in)	N/A
N/A	Shared Landing?	N/A			
N/A	Gutter Ponding?	N/A	N/A	Gutter Slope (%)	N/A
N/A	Gutter Lip Ht (in)	N/A	N/A	Gutter X Slope (%)	N/A
N/A	Painted X Walk1?	Yes	N/A	Painted X Walk2?	N/A
	X Walk 1 Direction	To NW		X Walk 2 Direction	N/A
N/A	X Walk 1 Width (in)	113.5	N/A	X Walk 2 Width (in)	N/A
	X Walk 1 Slope (%)	1.3		X Walk 2 Slope (%)	N/A
	X Walk 1 X Slope (%)	5.0		X Walk 2 X Slope (%)	N/A
N/A	Ramp inside XWalk1?	Yes	N/A	Ramp inside XWalk2?	N/A

Road Slope (%)	N/A	N/A	Clear Space?	N/A
	Road X Slope (%)	N/A	N/A	Clear Space to XWalk (in)	N/A
N/A	Any Obstructions?	N/A	N/A	Storm Grate/Utility Hazard?	N/A
	Obstruction Type			Storm Grate/Utility Type	
		N/A			N/A
			Yes	Surface Condition? (G/P)	Good
			N/A	Curb Slope (%)	3.7

Possible Solutions:

Remove & Replace Entire Ramp.
