Access Compliance Report

Public Rights-of-Way

(Curb Ramps)

Intersection ID: 14737	Main Street: CAMERON_AV	Cross Street: KENMORE_AV	Location: W
ADA ID: 2CA72F983338	Ramp Type: PerpDiag	Initial Pass/Fail: Fail	Overall Compliance: No
		Severity Score: 25

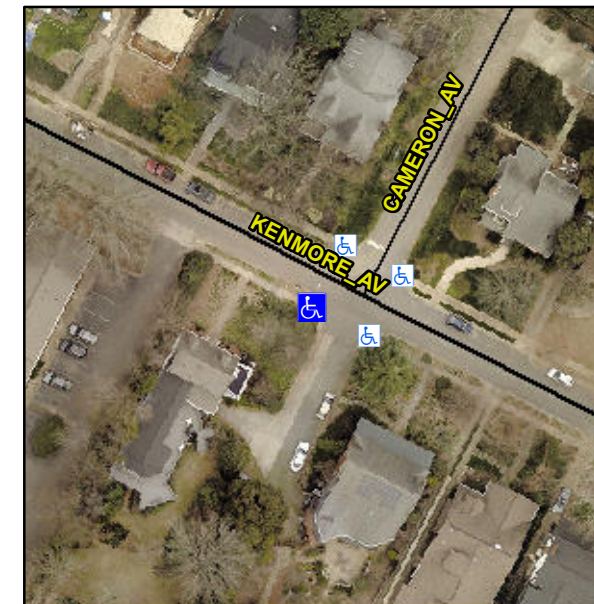
Not Found, R304.2.2, R304.5.3

Compliance	Description	Data	Compliance	Description	Data
N/A	Ramp Length (in)	35.0	No	Ramp Slope (%)	10.3
Yes	Ramp Width (in)	48.0	No	Ramp XSlope (%)	6.8
N/A	Flare Type LT	N/A	N/A	Flare Type RT	N/A
N/A	Flare Slope LT (%)	N/A	N/A	Flare Slope RT (%)	N/A
N/A	Flare Traversable LT?	N/A	N/A	Flare Traversable RT?	N/A
N/A	Landing Length (in)	N/A	N/A	DWS Provided?	N/A
N/A	Landing Width (in)	N/A	N/A	DWS Contrast?	N/A
N/A	Landing Slope (%)	N/A	N/A	DWS Length (in)	N/A
N/A	Landing X Slope (%)	N/A	N/A	DWS Full Width?	N/A
N/A	Landing Curb? (Y/N)	N/A	N/A	DWS Offset (in)	N/A
N/A	Shared Landing?	N/A			
N/A	Gutter Ponding?	N/A	N/A	Gutter Slope (%)	N/A
N/A	Gutter Lip Ht (in)	N/A	N/A	Gutter X Slope (%)	N/A
N/A	Painted X Walk1?	No	N/A	Painted X Walk2?	No
	X Walk 1 Direction	To SE		X Walk 2 Direction	To NE
N/A	X Walk 1 Width (in)	N/A	N/A	X Walk 2 Width (in)	N/A
	X Walk 1 Slope (%)	0.2		X Walk 2 Slope (%)	3.9
	X Walk 1 X Slope (%)	5.5		X Walk 2 X Slope (%)	1.5

N/A	Ramp inside XWalk1?	N/A	N/A	Ramp inside XWalk2?	N/A
	Road Slope (%)	6.6	N/A	Clear Space?	N/A
	Road X Slope (%)	2.6	N/A	Clear Space to XWalk (in)	N/A
N/A	Any Obstructions?	N/A	N/A	Storm Grate/Utility Hazard?	N/A
	Obstruction Type			Storm Grate/Utility Type	
		N/A			N/A
			Yes	Surface Condition? (G/P)	Good

Possible Solutions:

Remove & Replace Curb Ramp With Two New Directional Ramps or Equivalent.
