# Access Compliance Report

## Public Rights-of-Way

### (Curb Ramps)

Intersection ID: 30082	Main Street: VILLAGE SHOPPING CENTER DR N	Cross Street: J W CLAY BV	Location: NE
ADA ID: 2CA96870304E	Ramp Type: PerpDiag	Initial Pass/Fail: Fail	Overall Compliance: No
Severity Score: 31.25			
Codes/Mitigation Info/Possible Solution		Field Measurements/Component Compliance

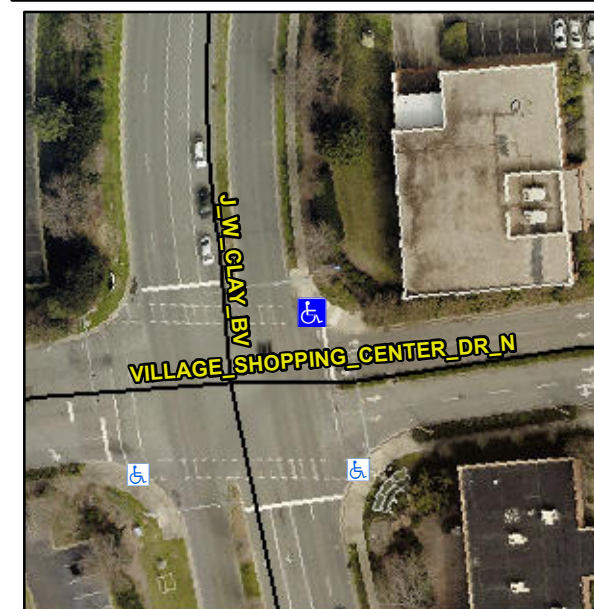
Compliance	Description	Data	Compliance	Description	Data
N/A	Ramp Length (in)	117.0	No	Ramp Slope (%)	9.0
No	Ramp Width (in)	32.0	No	Ramp XSlope (%)	2.8
N/A	Flare Type LT	N/A	N/A	Flare Type RT	N/A
N/A	Flare Slope LT (%)	N/A	N/A	Flare Slope RT (%)	N/A
N/A	Flare Traversable LT?	N/A	N/A	Flare Traversable RT?	N/A
N/A	Landing Length (in)	N/A	N/A	DWS Provided?	N/A
N/A	Landing Width (in)	N/A	N/A	DWS Contrast?	N/A
N/A	Landing Slope (%)	N/A	N/A	DWS Length (in)	N/A
N/A	Landing X Slope (%)	N/A	N/A	DWS Full Width?	N/A
N/A	Landing Curb? (Y/N)	N/A	N/A	DWS Offset (in)	N/A
N/A	Shared Landing?	N/A			
N/A	Gutter Ponding?	N/A	N/A	Gutter Slope (%)	N/A
N/A	Gutter Lip Ht (in)	N/A	N/A	Gutter X Slope (%)	N/A
N/A	Painted X Walk1?	Yes	N/A	Painted X Walk2?	Yes
	X Walk 1 Direction	To W		X Walk 2 Direction	To S
N/A	X Walk 1 Width (in)	103.0	N/A	X Walk 2 Width (in)	108.0
	X Walk 1 Slope (%)	2.9		X Walk 2 Slope (%)	0.2
	X Walk 1 X Slope (%)	0.5		X Walk 2 X Slope (%)	2.1

N/A	Ramp inside XWalk1?	Yes	N/A	Ramp inside XWalk2?	Yes
	Road Slope (%)	0.1	N/A	Clear Space?	N/A
	Road X Slope (%)	4.1	N/A	Clear Space to XWalk (in)	N/A
N/A	Any Obstructions?	N/A	N/A	Storm Grate/Utility Hazard?	N/A
	Obstruction Type			Storm Grate/Utility Type	
		N/A			N/A
		Yes		Surface Condition? (G/P)	Good

**Remove & Replace Curb Ramp With Two New Directional Ramps or Equivalent.**

**R304.5.1, R304.2.2, R304.5.3**
