Access Compliance Report

Public Rights-of-Way

(Curb Ramps)

Intersection ID: 50615	Main Street: FAWN_LILY	Cross Street: BALSAM_BAY_RD	Location: E
ADA ID: 2CAF38EA08FE	Ramp Type: Perp	Initial Pass/Fail: Fail	Overall Compliance: No
		Severity Score: 22.5	
Codes/Mitigation Info/Possible Solution		Field Measurements/Component Compliance

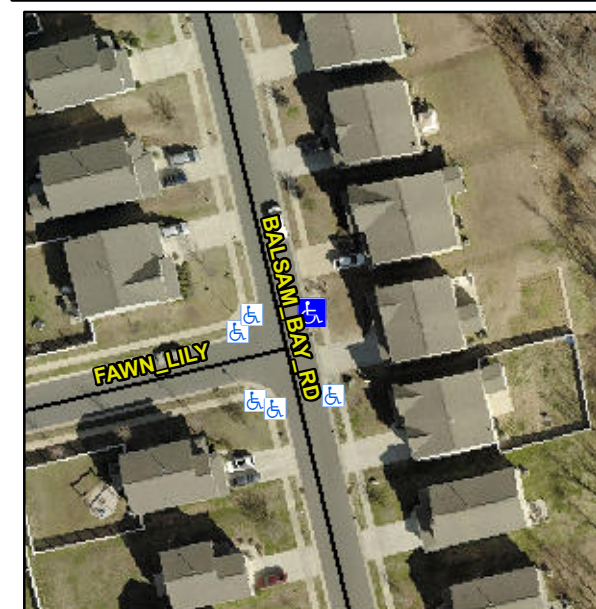
R304.5.1, R304.2.2, R304.5.3

Compliance	Description	Data	Compliance	Description	Data
N/A	Ramp Length (in)	48.0	No	Ramp Slope (%)	9.5
No	Ramp Width (in)	47.5	No	Ramp XSlope (%)	3.3
N/A	Flare Type LT	N/A	N/A	Flare Type RT	N/A
N/A	Flare Slope LT (%)	N/A	N/A	Flare Slope RT (%)	N/A
N/A	Flare Traversable LT?	N/A	N/A	Flare Traversable RT?	N/A
N/A	Landing Length (in)	N/A	N/A	DWS Provided?	N/A
N/A	Landing Width (in)	N/A	N/A	DWS Contrast?	N/A
N/A	Landing Slope (%)	N/A	N/A	DWS Length (in)	N/A
N/A	Landing X Slope (%)	N/A	N/A	DWS Full Width?	N/A
N/A	Landing Curb? (Y/N)	N/A	N/A	DWS Offset (in)	N/A
N/A	Shared Landing?	N/A			
N/A	Gutter Ponding?	N/A	N/A	Gutter Slope (%)	N/A
N/A	Gutter Lip Ht (in)	N/A	N/A	Gutter X Slope (%)	N/A
N/A	Painted X Walk1?	No	N/A	Painted X Walk2?	N/A
	X Walk 1 Direction	To W		X Walk 2 Direction	N/A
N/A	X Walk 1 Width (in)	N/A	N/A	X Walk 2 Width (in)	N/A
	X Walk 1 Slope (%)	2.6		X Walk 2 Slope (%)	N/A
	X Walk 1 X Slope (%)	2.5		X Walk 2 X Slope (%)	N/A

Possible Solutions:

Remove & Replace Entire Ramp.

Total Cost: \$ 1850.00
