## Access Compliance Report Public Rights-of-Way (Curb Ramps)

Intersection ID: 10034319 Main Street: PERIMETER\_PY Cross Street: N/A Location: NE

ADA ID: 2CB497494C34 Ramp Type: PerpDiag Initial Pass/Fail: Fail Overall Compliance: No Severity Score: 21.25

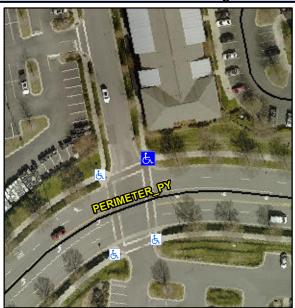
PROW/ADA:
Not Found, R304.5.1, R304.2.2

Field Measurements/Component Compliance						
	Compliance Description		Data	Comp	oliance Description	Data
	N/A	Ramp Length (in)	64.0	No	Ramp Slope (%)	9.4
	No	Ramp Width (in)	47.5	Yes	Ramp XSlope (%)	1.3
	N/A	Flare Type LT	N/A	N/A	Flare Type RT	N/A
	N/A	Flare Slope LT (%)	N/A	N/A	Flare Slope RT (%)	N/A
	N/A	Flare Traversable LT?	N/A	N/A	Flare Traversable RT?	N/A
	N/A	Landing Length (in)	N/A	N/A	DWS Provided?	N/A
	N/A	Landing Width (in)	N/A	N/A	DWS Contrast?	N/A
	N/A	Landing Slope (%)	N/A	N/A	DWS Length (in)	N/A
	N/A	Landing X Slope (%)	N/A	N/A	DWS Full Width?	N/A
	N/A	Landing Curb? (Y/N)	N/A	N/A	DWS Offset (in)	N/A
	N/A	Shared Landing?	N/A			
	N/A	Gutter Ponding?	N/A	N/A	Gutter Slope (%)	N/A
	N/A	Gutter Lip Ht (in)	N/A	N/A	Gutter X Slope (%)	N/A
	N/A	Painted X Walk1?	Yes	N/A	Painted X Walk2?	Yes
		X Walk 1 Direction	To W		X Walk 2 Direction	To S
	N/A	X Walk 1 Width (in)	72.0	N/A	X Walk 2 Width (in)	72.0
		X Walk 1 Slope (%)	0.1		X Walk 2 Slope (%)	2.3

X Walk 1 X Slope (%)	0.9		X Walk 2 X Slope (%)	1.2
	N/A	Ramp inside XWalk1?	Yes	N/A	Ramp inside XWalk2?	Yes
		Road Slope (%)	0.6	N/A	Clear Space?	N/A
		Road X Slope (%)	0.0	N/A	Clear Space to XWalk (in)	N/A
	N/A	Any Obstructions?	N/A	N/A	Storm Grate/Utility Hazard?	N/A
		Obstruction Type			Storm Grate/Utility Type	
			N/A			N/A
				Yes	Surface Condition? (G/P)	Good

ENTRANCE StopSign PERIMETER PY None Possible Solutions:

Remove & Replace Curb Ramp With
Two New Directional Ramps or
Equivalent.
