# Access Compliance Report

## Public Rights-of-Way

### (Curb Ramps)

Intersection ID: 49647	Main Street: STRAWBERRY_LN	Cross Street: GREENBRIAR_HILLS_PLANTATION_RD	Location: NW
ADA ID: 2CB4BD592F0B	Ramp Type: PerpDiag	Initial Pass/Fail: Pass	Overall Compliance: No
		Severity Score: 10

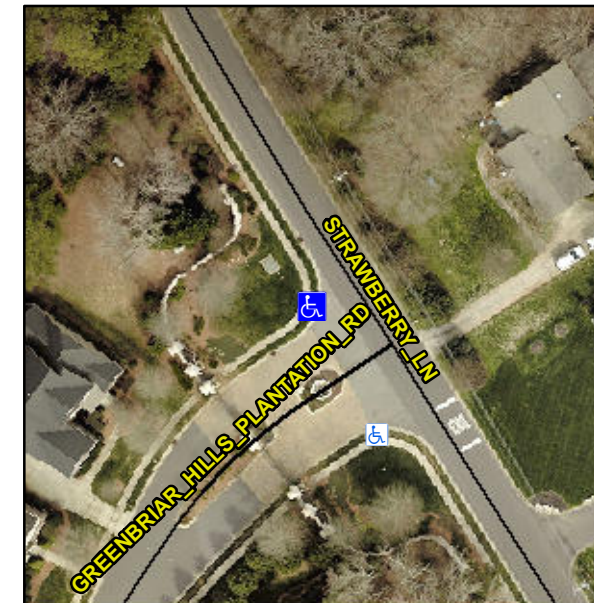
**Not Found, R304.2.1, R304.2.2-Perp, R304.3.2-Para, R304.5.3, R305.2**

Compliance	Description	Data	Compliance	Description	Data
N/A	Ramp Length (in)	97.0	Yes	Ramp Slope (%)	5.5
Yes	Ramp Width (in)	48.0	Yes	Ramp XSlope (%)	1.4
N/A	Flare Type LT	Sloped	N/A	Flare Type RT	N/A
N/A	Flare Slope LT (%)	5.0	Yes	Flare Slope RT (%)	4.1
N/A	Flare Traversable LT?	Yes	N/A	Flare Traversable RT?	Yes
No	Landing Length (in)	N/A	Yes	DWS Provided?	Yes
No	Landing Width (in)	N/A	Yes	DWS Contrast?	Yes
No	Landing Slope (%)	N/A	Yes	DWS Length (in)	24.5
No	Landing X Slope (%)	N/A	Yes	DWS Full Width?	Yes
N/A	Landing Curb? (Y/N)	No	No	DWS Offset (in)	2.5
N/A	Shared Landing?	No			
Yes	Gutter Ponding?	No	Yes	Gutter Slope (%)	0.7
Yes	Gutter Lip Ht (in)	0.0	Yes	Gutter X Slope (%)	0.8
N/A	Painted X Walk1?	No	N/A	Painted X Walk2?	No
	X Walk 1 Direction	To SE		X Walk 2 Direction	To NE
N/A	X Walk 1 Width (in)	N/A	N/A	X Walk 2 Width (in)	N/A
	X Walk 1 Slope (%)	1.1		X Walk 2 Slope (%)	1.3
	X Walk 1 X Slope (%)	1.5		X Walk 2 X Slope (%)	2.3

N/A	Ramp inside XWalk1?	N/A	N/A	Ramp inside XWalk2?	N/A
	Road Slope (%)	1.0	N/A	Clear Space?	Yes
	Road X Slope (%)	3.0	N/A	Clear Space to XWalk (in)	N/A
Yes	Any Obstructions?	No	Yes	Storm Grate/Utility Hazard?	No
	Obstruction Type			Storm Grate/Utility Type	
		N/A			N/A
			Yes	Surface Condition? (G/P)	Good

**Remove & Replace Curb Ramp With Two New Directional Ramps or Equivalent.**
