Access Compliance Report

Public Rights-of-Way

(Curb Ramps)

Intersection ID: 10035658	Main Street: RED_OAK_BV	Cross Street: N/A	Location: SW
ADA ID: 2CB7569D0800	Ramp Type: MedianPerp	Initial Pass/Fail: Pass	Overall Compliance: No
Codes/Mitigation Info/Possible Solution		Field Measurements/Component Compliance

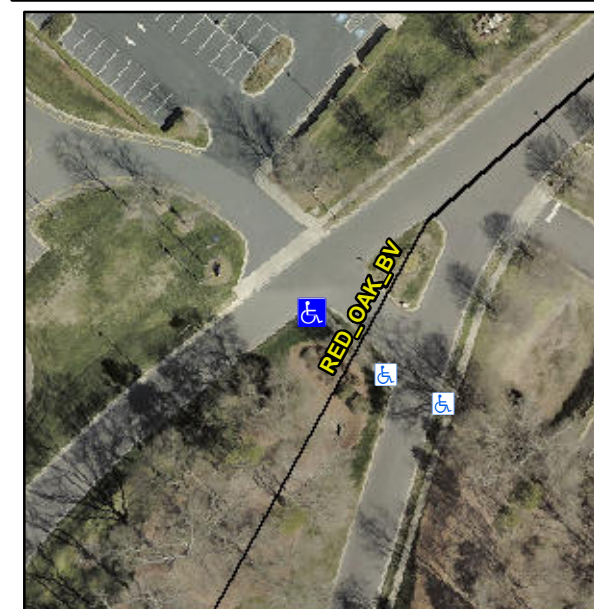
Compliance	Description	Data	Compliance	Description	Data
N/A	Ramp Length (in)	52.0	Yes	Ramp Slope (%)	6.0
Yes	Ramp Width (in)	48.0	Yes	Ramp XSlope (%)	2.3
N/A	Flare Type LT	Sloped	N/A	Flare Type RT	N/A
N/A	Flare Slope LT (%)	7.0	N/A	Flare Slope RT (%)	1.2
N/A	Flare Traversable LT?	Yes	N/A	Flare Traversable RT?	No
No	Landing Length (in)	N/A	Yes	DWS Provided?	Yes
No	Landing Width (in)	N/A	Yes	DWS Contrast?	Yes
No	Landing Slope (%)	N/A	Yes	DWS Length (in)	24.0
No	Landing X Slope (%)	N/A	Yes	DWS Full Width?	Yes
N/A	Landing Curb? (Y/N)	N/A	Yes	DWS Offset (in)	0.0
N/A	Shared Landing?	No			
Yes	Gutter Ponding?	No	Yes	Gutter Slope (%)	1.6
Yes	Gutter Lip Ht (in)	0.0	No	Gutter X Slope (%)	4.0
N/A	Painted X Walk1?	No	N/A	Painted X Walk2?	N/A
	X Walk 1 Direction	To N		X Walk 2 Direction	N/A
N/A	X Walk 1 Width (in)	N/A	N/A	X Walk 2 Width (in)	N/A
	X Walk 1 Slope (%)	3.1		X Walk 2 Slope (%)	N/A
	X Walk 1 X Slope (%)	2.8		X Walk 2 X Slope (%)	N/A

N/A	Ramp inside XWalk1?	N/A	N/A	Ramp inside XWalk2?	N/A
	Road Slope (%)	N/A	N/A	Clear Space?	Yes
	Road X Slope (%)	N/A	N/A	Clear Space to XWalk (in)	N/A
Yes	Any Obstructions?	No	Yes	Storm Grate/Utility Hazard?	No
	Obstruction Type			Storm Grate/Utility Type	
		N/A			N/A
			Yes	Surface Condition? (G/P)	Good

Install Landing. Remove & Replace Gutter.

R304.2.1, R304.2.2-Perp, R304.3.2-Para, R304.5.3
