Access Compliance Report

Public Rights-of-Way

(Curb Ramps)

Intersection ID: 48000	Main Street: LANZERAC_MANOR_DR	Cross Street: CLYMER_CT	Location: NW
ADA ID: 2CCF65B433FF	Ramp Type: Perp	Initial Pass/Fail: Fail	Overall Compliance: No
Severity Score: 22.5			
Codes/Mitigation Info/Possible Solution		Field Measurements/Component Compliance

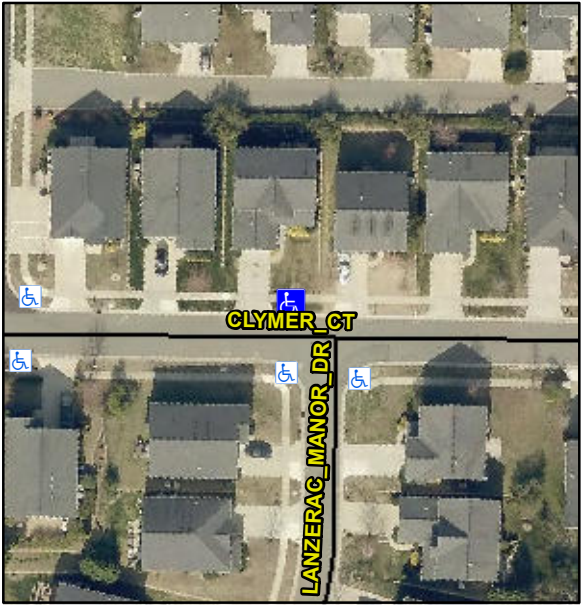
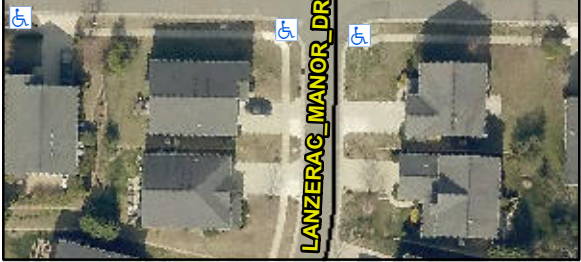
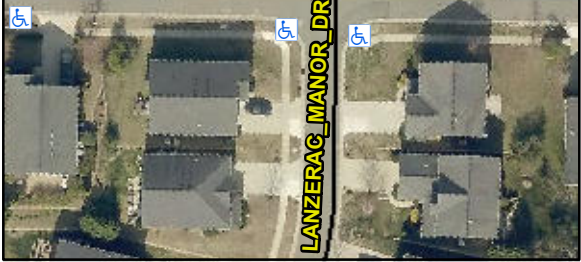
PROW/ADA:			
	Not Found, R304.5.1, R304.2.2, R304.5.3			
Street 1 Name	CLYMER CT			
Stop Condition-Street 2	None			
Street 2 Name	N/A			
Stop Condition-Street 1	N/A			
Total Cost:		\$	1850.00

Compliance	Description	Data	Compliance	Description	Data
N/A	Ramp Length (in)	70.5	No	Ramp Slope (%)	9.6
No	Ramp Width (in)	47.0	No	Ramp XSlope (%)	4.4
N/A	Flare Type LT	N/A	N/A	Flare Type RT	N/A
N/A	Flare Slope LT (%)	N/A	N/A	Flare Slope RT (%)	N/A
N/A	Flare Traversable LT?	N/A	N/A	Flare Traversable RT?	N/A
N/A	Landing Length (in)	N/A	N/A	DWS Provided?	N/A
N/A	Landing Width (in)	N/A	N/A	DWS Contrast?	N/A
N/A	Landing Slope (%)	N/A	N/A	DWS Length (in)	N/A
N/A	Landing X Slope (%)	N/A	N/A	DWS Full Width?	N/A
N/A	Landing Curb? (Y/N)	N/A	N/A	DWS Offset (in)	N/A
N/A	Shared Landing?	N/A			
N/A	Gutter Ponding?	N/A	N/A	Gutter Slope (%)	N/A
N/A	Gutter Lip Ht (in)	N/A	N/A	Gutter X Slope (%)	N/A
N/A	Painted X Walk1?	No	N/A	Painted X Walk2?	N/A
	X Walk 1 Direction	To S		X Walk 2 Direction	N/A
N/A	X Walk 1 Width (in)	N/A	N/A	X Walk 2 Width (in)	N/A
	X Walk 1 Slope (%)	2.0		X Walk 2 Slope (%)	N/A
	X Walk 1 X Slope (%)	4.0		X Walk 2 X Slope (%)	N/A

N/A	Ramp inside XWalk1?	N/A	N/A	Ramp inside XWalk2?	N/A
	Road Slope (%)	N/A	N/A	Clear Space?	N/A
	Road X Slope (%)	N/A	N/A	Clear Space to XWalk (in)	N/A
N/A	Any Obstructions?	N/A	N/A	Storm Grate/Utility Hazard?	N/A
	Obstruction Type			Storm Grate/Utility Type	
		N/A			N/A
			Yes	Surface Condition? (G/P)	Good

Possible Solutions:			
	Remove & Replace Entire Ramp.
