Access Compliance Report

Public Rights-of-Way

(Curb Ramps)

Intersection ID: 54218	Main Street: GOLF_LINKS_DR	Cross Street: SANDY_ROCK_PL	Location: NE
ADA ID: 2CD4B8372446	Ramp Type: Perp	Initial Pass/Fail: Fail	Overall Compliance: No
Severity Score: 12.5			
Codes/Mitigation Info/Possible Solution		Field Measurements/Component Compliance

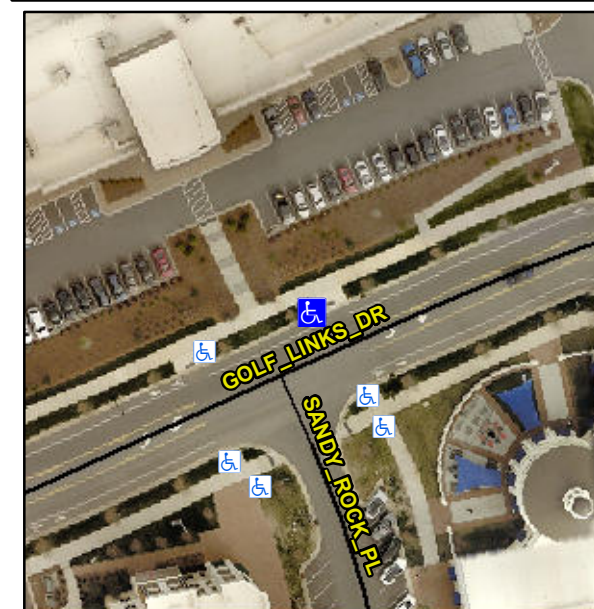
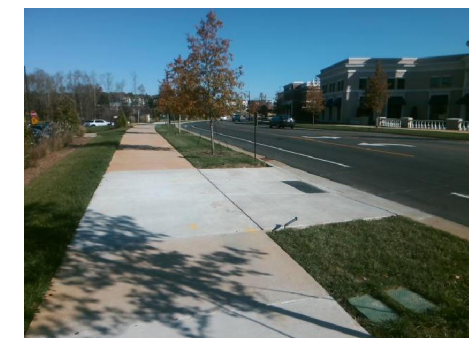
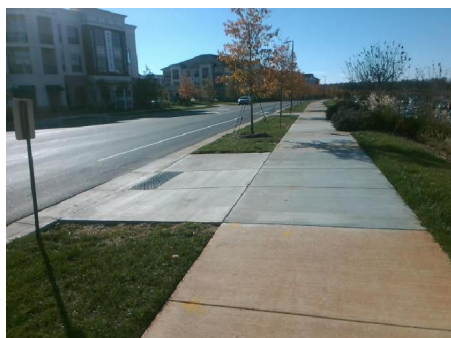
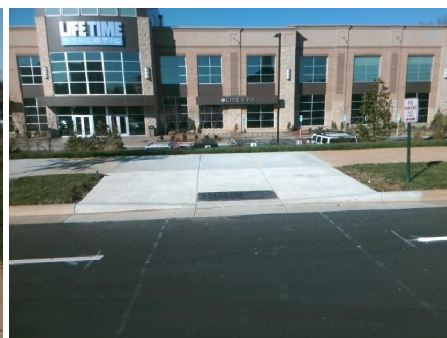
Not Found, R304.2.2

Compliance	Description	Data	Compliance	Description	Data
N/A	Ramp Length (in)	96.0	No	Ramp Slope (%)	8.6
Yes	Ramp Width (in)	60.0	Yes	Ramp XSlope (%)	1.6
N/A	Flare Type LT	N/A	N/A	Flare Type RT	N/A
N/A	Flare Slope LT (%)	N/A	N/A	Flare Slope RT (%)	N/A
N/A	Flare Traversable LT?	N/A	N/A	Flare Traversable RT?	N/A
N/A	Landing Length (in)	N/A	N/A	DWS Provided?	N/A
N/A	Landing Width (in)	N/A	N/A	DWS Contrast?	N/A
N/A	Landing Slope (%)	N/A	N/A	DWS Length (in)	N/A
N/A	Landing X Slope (%)	N/A	N/A	DWS Full Width?	N/A
N/A	Landing Curb? (Y/N)	N/A	N/A	DWS Offset (in)	N/A
N/A	Shared Landing?	N/A			
N/A	Gutter Ponding?	N/A	N/A	Gutter Slope (%)	N/A
N/A	Gutter Lip Ht (in)	N/A	N/A	Gutter X Slope (%)	N/A
N/A	Painted X Walk1?	No	N/A	Painted X Walk2?	N/A
	X Walk 1 Direction	To SE		X Walk 2 Direction	N/A
N/A	X Walk 1 Width (in)	N/A	N/A	X Walk 2 Width (in)	N/A
	X Walk 1 Slope (%)	6.5		X Walk 2 Slope (%)	N/A
	X Walk 1 X Slope (%)	1.5		X Walk 2 X Slope (%)	N/A

Remove & Replace Entire Ramp.
