Access Compliance Report Public Rights-of-Way (Curb Ramps)

Intersection ID: 28334 Main Street: CASTLEBAY_DR Cross Street: NETHERFIELD_CT Location: S

ADA ID: 2CDA377981CB Ramp Type: BlendTrans2 Initial Pass/Fail: Fail Overall Compliance: No Severity Score: 12.5

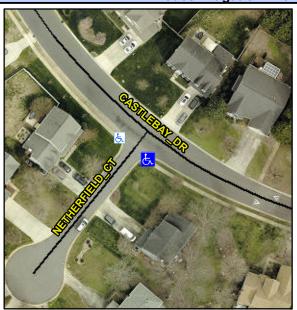
Not Found, R304.5.3

r leid Measurements/Component Compilance					
Compliance Description		Data	Compliance Description		Data
N/A	Ramp Length (in)	62.0	Yes	BlendTrans Slope (%)	4.5
Yes	Ramp Width (in)	48.0	No	BlendTrans XSlope (%)	5.6
N/A	Flare Type LT	N/A	N/A	Flare Type RT	N/A
N/A	Flare Slope LT (%)	N/A	N/A	Flare Slope RT (%)	N/A
N/A	Flare Traversable LT?	N/A	N/A	Flare Traversable RT?	N/A
N/A	Landing Length (in)	N/A	N/A	DWS Provided?	N/A
N/A	Landing Width (in)	N/A	N/A	DWS Contrast?	N/A
N/A	Landing Slope (%)	N/A	N/A	DWS Length (in)	N/A
N/A	Landing X Slope (%)	N/A	N/A	DWS Full Width?	N/A
N/A	Landing Curb? (Y/N)	N/A	N/A	DWS Offset (in)	N/A
N/A	Shared Landing?	N/A			
N/A	Gutter Ponding?	N/A	N/A	Gutter Slope (%)	N/A
N/A	Gutter Lip Ht (in)	N/A	N/A	Gutter X Slope (%)	N/A
N/A	Painted X Walk1?	No	N/A	Painted X Walk2?	No
	X Walk 1 Direction	To NE		X Walk 2 Direction	To NW
	X Walk 1 Width (in)	N/A		X Walk 2 Width (in)	N/A
	X Walk 1 Slope (%)	1.6		X Walk 2 Slope (%)	2.3

X Walk 1 X Slope (%)	2.6		X Walk 2 X Slope (%)	2.8
N/A	Ramp inside XWalk1?	N/A	N/A	Ramp inside XWalk2?	N/A
	Road Slope (%)	2.7		Clear Space?	N/A
	Road X Slope (%)	0.1	N/A	Clear Space to XWalk (in)	N/A
N/A	Any Obstructions?	N/A	N/A	Storm Grate/Utility Hazard?	N/A

CASTLEBAY DR None NETHERFIELD CT StopSign Possible Solutions:

Remove & Replace Curb Ramp With Two New Directional Ramps or Equivalent.
