Access Compliance Report

Public Rights-of-Way

(Curb Ramps)

Intersection ID: N/A	Main Street: BRENTMOOR DR	Cross Street: PIKE RD	Location: SW
ADA ID: 2CDC1D26AC4A	Ramp Type: Para	Initial Pass/Fail: Fail	Overall Compliance: No
			Severity Score: 1.25

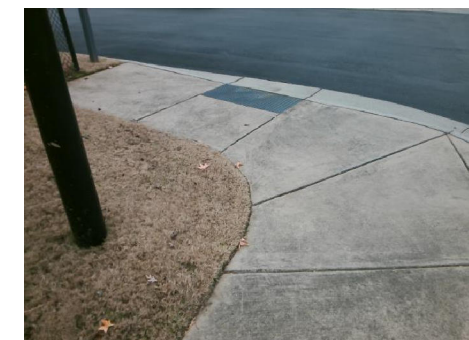
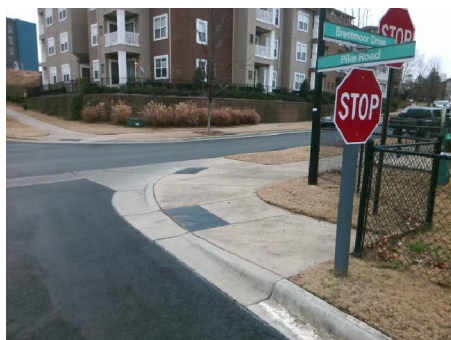
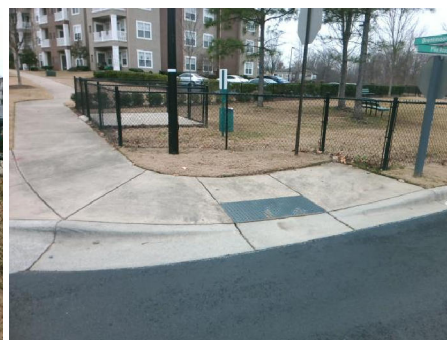
Compliance	Description	Data	Compliance	Description	Data
N/A	Ramp Length LT (in)	36.0	N/A	Ramp Length RT (in)	67.0
Yes	Ramp Width LT (in)	77.0	Yes	Ramp Width RT (in)	72.0
Yes	Ramp Slope LT (%)	5.2	Yes	Ramp Slope RT (%)	5.8
Yes	Ramp XSlope LT (%)	1.5	No	Ramp XSlope RT (%)	2.5
N/A	Landing Length (in)	N/A	N/A	DWS Provided?	N/A
N/A	Landing Width (in)	N/A	N/A	DWS Contrast?	N/A
N/A	Landing Slope (%)	N/A	N/A	DWS Length (in)	N/A
N/A	Landing X Slope (%)	N/A	N/A	DWS Full Width?	N/A
N/A	Landing Curb? (Y/N)	N/A	N/A	DWS Offset (in)	N/A
N/A	Shared Landing?	N/A			
N/A	Gutter Ponding?	N/A	N/A	Gutter Slope (%)	N/A
N/A	Gutter Lip Ht (in)	N/A	N/A	Gutter X Slope (%)	N/A
N/A	Painted X Walk1?	No	N/A	Painted X Walk2?	N/A
	X Walk 1 Direction	To N		X Walk 2 Direction	N/A
N/A	X Walk 1 Width (in)	N/A	N/A	X Walk 2 Width (in)	N/A
	X Walk 1 Slope (%)	3.4		X Walk 2 Slope (%)	N/A
	X Walk 1 X Slope (%)	0.4		X Walk 2 X Slope (%)	N/A
N/A	Ramp inside XWalk1?	N/A	N/A	Ramp inside XWalk2?	N/A

Road Slope (%)	N/A	N/A	Clear Space?	N/A
	Road X Slope (%)	N/A	N/A	Clear Space to XWalk (in)	N/A
N/A	Any Obstructions?	N/A	N/A	Storm Grate/Utility Hazard?	N/A
	Obstruction Type			Storm Grate/Utility Type	
		N/A			N/A
			Yes	Surface Condition? (G/P)	Good
			N/A	Curb Slope (%)	12.7

Remove & Replace Entire Ramp.

R304.5.3
