# Access Compliance Report

## Public Rights-of-Way

### (Curb Ramps)

Intersection ID: 18814	Main Street: COLONY_RD	Cross Street: FERNCLIFF_RD	Location: SW
ADA ID: 2CE27B17CC85	Ramp Type: PerpDiag	Initial Pass/Fail: Fail	Overall Compliance: No
		Severity Score: 13.75

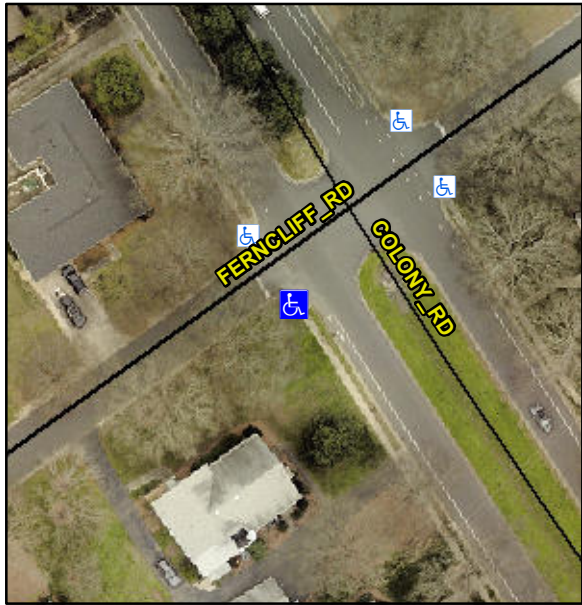
Possible Solutions:		Compliance	Description	Data	Compliance	Description	Data
	Remove & Replace Curb Ramp With Two New Directional Ramps or Equivalent.		N/A	Ramp Length (in)	64.0	No	Ramp Slope (%)	8.8
			Yes	Ramp Width (in)	48.0	No	Ramp XSlope (%)	2.2
			N/A	Flare Type LT	N/A	N/A	Flare Type RT	N/A
			N/A	Flare Slope LT (%)	N/A	N/A	Flare Slope RT (%)	N/A
			N/A	Flare Traversable LT?	N/A	N/A	Flare Traversable RT?	N/A
			N/A	Landing Length (in)	N/A	N/A	DWS Provided?	N/A
			N/A	Landing Width (in)	N/A	N/A	DWS Contrast?	N/A
			N/A	Landing Slope (%)	N/A	N/A	DWS Length (in)	N/A
			N/A	Landing X Slope (%)	N/A	N/A	DWS Full Width?	N/A
Surveyor Notes:		N/A	N/A	Landing Curb? (Y/N)	N/A	N/A	DWS Offset (in)	N/A
PROW/ADA:		Not Found, R304.2.2, R304.5.3	N/A	Shared Landing?	N/A			
			N/A	Gutter Ponding?	N/A	N/A	Gutter Slope (%)	N/A

N/A	Gutter Lip Ht (in)	N/A	N/A	Gutter X Slope (%)	N/A
			N/A	Painted X Walk1?	No	N/A	Painted X Walk2?	No
				X Walk 1 Direction	To NE		X Walk 2 Direction	To N
			N/A	X Walk 1 Width (in)	N/A	N/A	X Walk 2 Width (in)	N/A
				X Walk 1 Slope (%)	7.4		X Walk 2 Slope (%)	3.0
				X Walk 1 X Slope (%)	0.3		X Walk 2 X Slope (%)	1.2
			N/A	Ramp inside XWalk1?	N/A	N/A	Ramp inside XWalk2?	N/A
				Road Slope (%)	0.5	N/A	Clear Space?	N/A
				Road X Slope (%)	2.8	N/A	Clear Space to XWalk (in)	N/A
			N/A	Any Obstructions?	N/A	N/A	Storm Grate/Utility Hazard?	N/A
				Obstruction Type			Storm Grate/Utility Type	
					N/A			N/A
						Yes	Surface Condition? (G/P)	Good
Street 1 Name		COLONY RD						
Stop Condition-Street 2		None						
Street 2 Name		FERNCLIFF RD						
Stop Condition-Street 1		StopSign						
Total Cost:		\$ 3200.00
