# Access Compliance Report

## Public Rights-of-Way (Curb Ramps)

| Intersection ID: 53894 | Main Street: INVERNESS_BAY_RD | Cross Street: PERTH_MOOR_RD | Location: SW |
| ADA ID: 2CEF784CC577 | Ramp Type: Perp | Initial Pass/Fail: Fail | Overall Compliance: No |

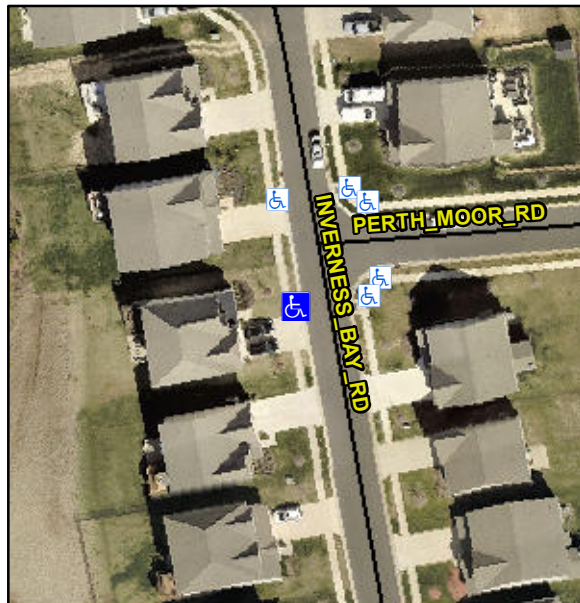
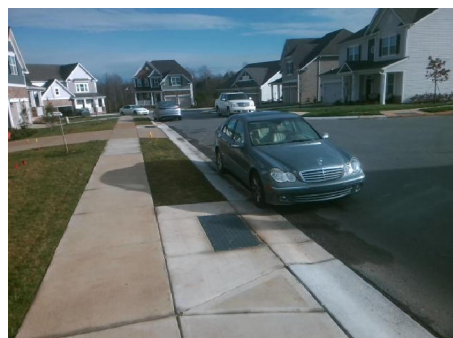
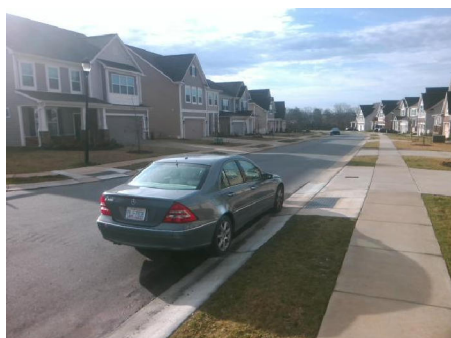
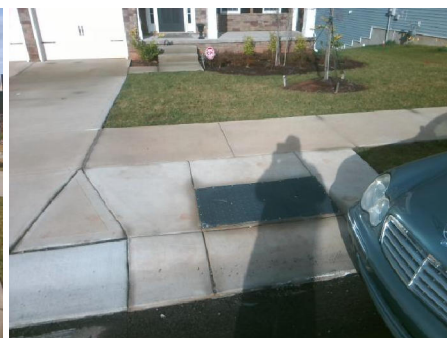
**Not Found, R304.5.1, R304.2.2**

| Compliance | Description | Data | Compliance | Description | Data |
|---|---|---|---|---|---|
| N/A | Ramp Length (in) | 48.0 | No | Ramp Slope (%) | 9.2 |
| No | Ramp Width (in) | 47.0 | Yes | Ramp XSlope (%) | 1.2 |
| N/A | Gutter Lip Ht (in) | 1.0 | N/A | Gutter X Slope (%) | N/A |

**Remove & Replace Entire Ramp.**
