# Access Compliance Report

## Public Rights-of-Way

### (Curb Ramps)

| Intersection ID: 50494 | Main Street: BLAIREBETH_ST | Cross Street: HAWFIELD_WAY_DR | Location: SE |

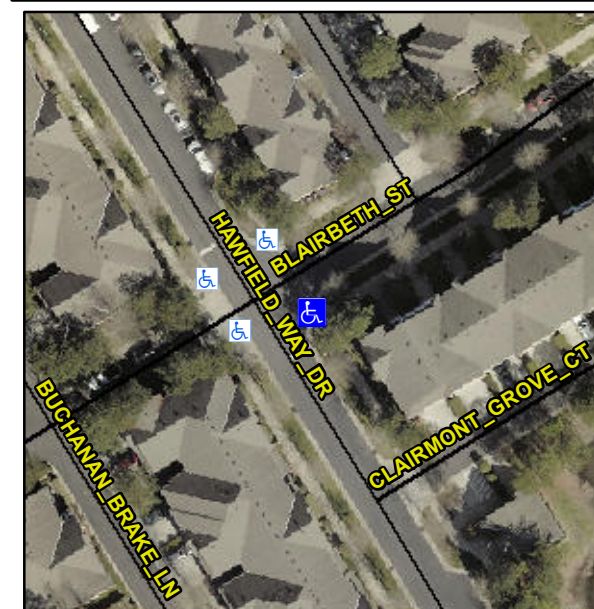
| ADA ID: 2CF05B67AA15 | Ramp Type: PerpDiag | Initial Pass/Fail: Fail | Overall Compliance: No |
| Severity Score: 12.5 | | | |

| Compliance | Description | Data | Compliance | Description | Data |
|---|---|---|---|---|---|
| Yes | Ramp Width (in) | 48.0 | No | Ramp XSlope (%) | 5.7 |

**Remove & Replace Curb Ramp With Two New Directional Ramps or Equivalent.**

**R304.5.3**

Total Cost: \$ 3200.00
