# Access Compliance Report

## Public Rights-of-Way

### (Curb Ramps)

| Intersection ID: 14095 | Main Street: CAMDEN_RD | Cross Street: W_WORTHINGTON_AV | Location: SW |

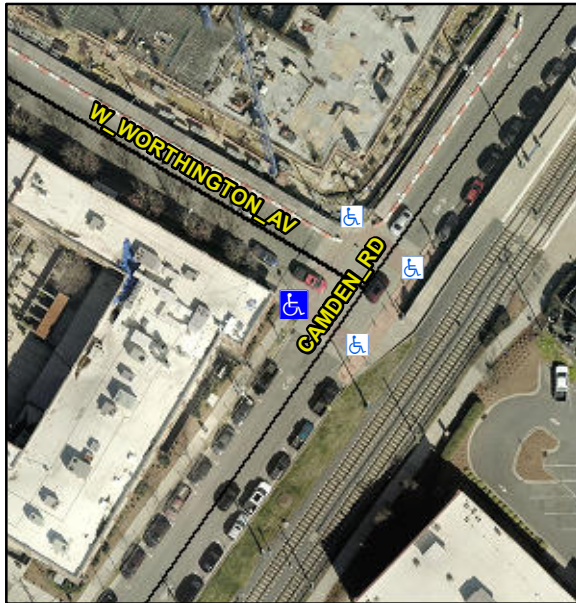
**Not Found, R304.5.1**

| Compliance | Description | Data | Compliance | Description | Data |
|---|---|---|---|---|---|
| No | Ramp Width (in) | 43.0 | Yes | BlendTrans XSlope (%) | 1.0 |
| | | | No | Curb Slope (%) | 11.1 |

**Remove & Replace Curb Ramp With Two New Directional Ramps or Equivalent.**

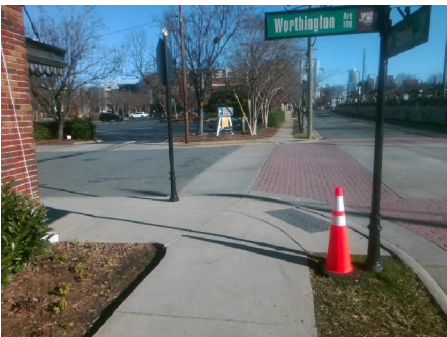
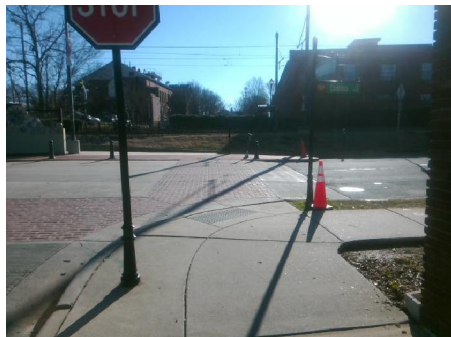
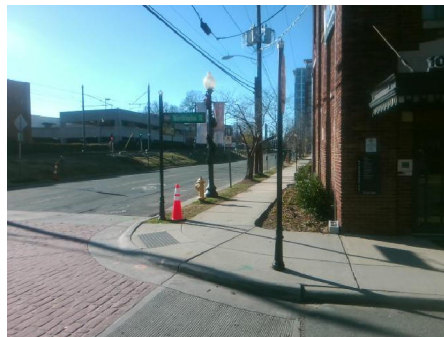
| ADA ID: 2CF728BF9D89 | Ramp Type: BlendTrans2 | Initial Pass/Fail: Fail | Overall Compliance: No |
