Access Compliance Report

Public Rights-of-Way

(Curb Ramps)

Intersection ID: 11685	Main Street: E_19TH_ST	Cross Street: SEIGLE_AV	Location: E
ADA ID: 2CF936627B27	Ramp Type: BlendTrans1	Initial Pass/Fail: Fail	Overall Compliance: No
Severity Score: 12.5			
Codes/Mitigation Info/Possible Solution		Field Measurements/Component Compliance

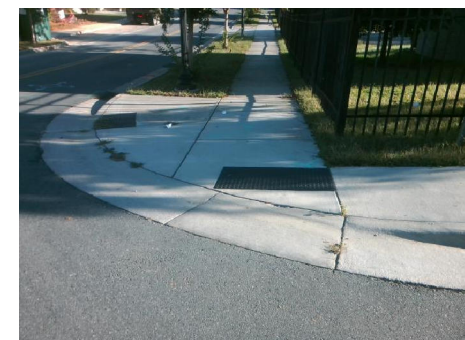
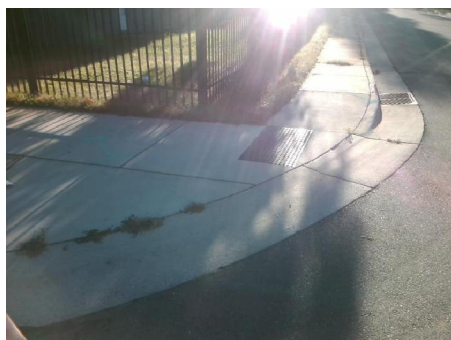
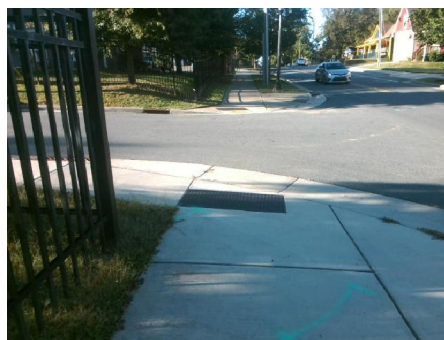
Not Found, R304.5.3

Compliance	Description	Data	Compliance	Description	Data
N/A	Ramp Length (in)	56.0	Yes	BlendTrans Slope (%)	0.4
Yes	Ramp Width (in)	48.0	No	BlendTrans XSlope (%)	6.5
N/A	Flare Type LT	N/A	N/A	Flare Type RT	N/A
N/A	Flare Slope LT (%)	N/A	N/A	Flare Slope RT (%)	N/A
N/A	Flare Traversable LT?	N/A	N/A	Flare Traversable RT?	N/A
N/A	Landing Length (in)	N/A	N/A	DWS Provided?	N/A
N/A	Landing Width (in)	N/A	N/A	DWS Contrast?	N/A
N/A	Landing Slope (%)	N/A	N/A	DWS Length (in)	N/A
N/A	Landing X Slope (%)	N/A	N/A	DWS Full Width?	N/A
N/A	Landing Curb? (Y/N)	N/A	N/A	DWS Offset (in)	N/A
N/A	Shared Landing?	N/A			
N/A	Gutter Ponding?	N/A	N/A	Gutter Slope (%)	N/A
N/A	Gutter Lip Ht (in)	N/A	N/A	Gutter X Slope (%)	N/A
N/A	Painted X Walk1?	No	N/A	Painted X Walk2?	N/A
	X Walk 1 Direction	To SW		X Walk 2 Direction	N/A
	X Walk 1 Width (in)	N/A		X Walk 2 Width (in)	N/A
	X Walk 1 Slope (%)	3.1		X Walk 2 Slope (%)	N/A
	X Walk 1 X Slope (%)	3.6		X Walk 2 X Slope (%)	N/A

N/A	Ramp inside XWalk1?	N/A	N/A	Ramp inside XWalk2?	N/A
	Road Slope (%)	3.6		Clear Space?	N/A
	Road X Slope (%)	3.1	N/A	Clear Space to XWalk (in)	N/A
N/A	Any Obstructions?	N/A	N/A	Storm Grate/Utility Hazard?	N/A
	Obstruction Type			Storm Grate/Utility Type	
		N/A			N/A
			Yes	Surface Condition? (G/P)	Good
			No	Curb Slope (%)	10.2

Remove & Replace Curb Ramp With Two New Directional Ramps or Equivalent.
