# Access Compliance Report

## Public Rights-of-Way (Curb Ramps)

Intersection ID: 13895	Main Street: ELIZABETH_AV	Cross Street: TRAVIS_AV	Location:	N
ADA ID: 2CFF4739FBB0	Ramp Type: BlendTrans1	Initial Pass/Fail: Fail	Overall Compliance: No	Severity Score: 10

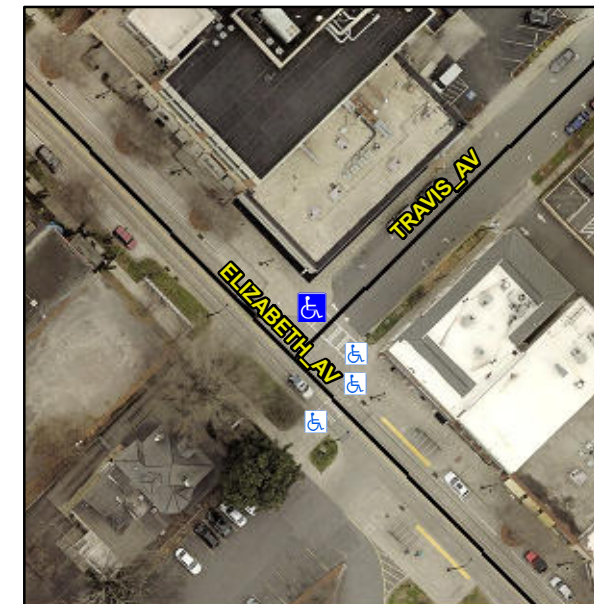
### Field Measurements/Component Compliance

**GTR GAP 1.0**

**Not Found, R304.5.1, R304.5.3**

Compliance	Description	Data	Compliance	Description	Data
N/A	Ramp Length (in)	71.0	Yes	BlendTrans Slope (%)	3.7
No	Ramp Width (in)	47.5	No	BlendTrans XSlope (%)	3.0
N/A	Flare Type LT	N/A	N/A	Flare Type RT	N/A
N/A	Flare Slope LT (%)	N/A	N/A	Flare Slope RT (%)	N/A
N/A	Flare Traversable LT?	N/A	N/A	Flare Traversable RT?	N/A
N/A	Landing Length (in)	N/A	N/A	DWS Provided?	N/A
N/A	Landing Width (in)	N/A	N/A	DWS Contrast?	N/A
N/A	Landing Slope (%)	N/A	N/A	DWS Length (in)	N/A
N/A	Landing X Slope (%)	N/A	N/A	DWS Full Width?	N/A
N/A	Landing Curb? (Y/N)	N/A	N/A	DWS Offset (in)	N/A
N/A	Shared Landing?	N/A			
N/A	Gutter Ponding?	N/A	N/A	Gutter Slope (%)	N/A
N/A	Gutter Lip Ht (in)	N/A	N/A	Gutter X Slope (%)	N/A
N/A	Painted X Walk1?	Yes	N/A	Painted X Walk2?	N/A
	X Walk 1 Direction	To SE		X Walk 2 Direction	N/A
	X Walk 1 Width (in)	113.0		X Walk 2 Width (in)	N/A
	X Walk 1 Slope (%)	3.6		X Walk 2 Slope (%)	N/A
	X Walk 1 X Slope (%)	1.5		X Walk 2 X Slope (%)	N/A

N/A	Ramp inside XWalk1?	Yes	N/A	Ramp inside XWalk2?	N/A
	Road Slope (%)	1.5		Clear Space?	N/A
	Road X Slope (%)	3.6	N/A	Clear Space to XWalk (in)	N/A
N/A	Any Obstructions?	N/A	N/A	Storm Grate/Utility Hazard?	N/A
	Obstruction Type			Storm Grate/Utility Type	
		N/A			N/A
			Yes	Surface Condition? (G/P)	Good
			No	Curb Slope (%)	21.2

**Remove & Replace Curb Ramp With Two New Directional Ramps or Equivalent.**
