# Access Compliance Report

## Public Rights-of-Way

### (Curb Ramps)

Intersection ID: 12594	Main Street: REMOUNT_RD	Cross Street: WILKINSON_BV	Location: NW
ADA ID: 2D03AF0D28F4	Ramp Type: BlendTrans1	Initial Pass/Fail: Fail	Overall Compliance: No
		Severity Score: 8.75

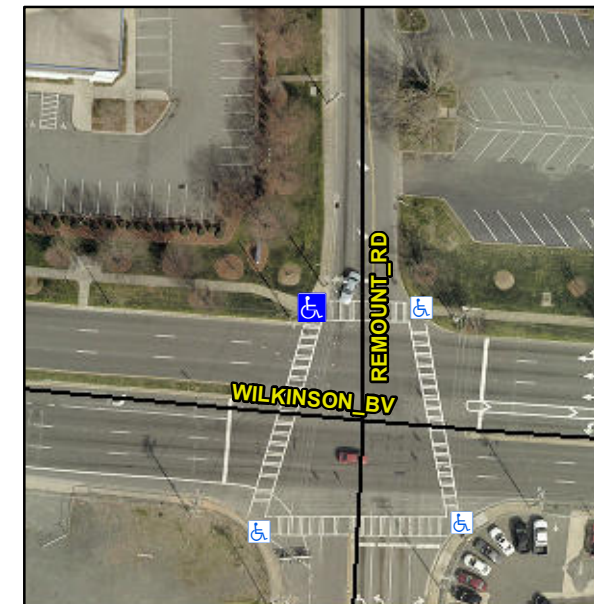
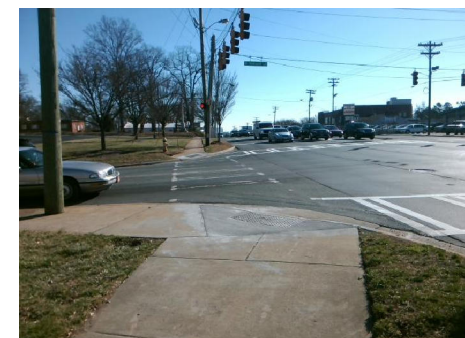
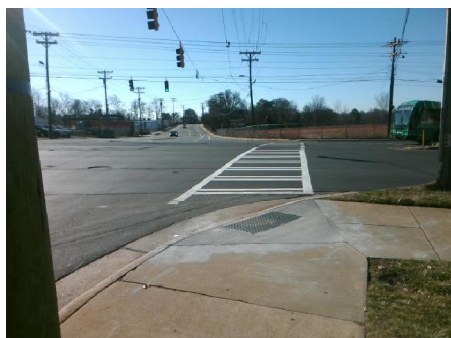
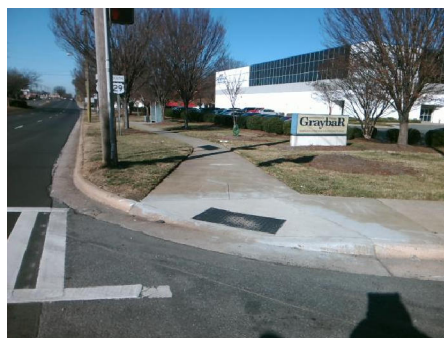
**Not Found, R304.5.1**

Compliance	Description	Data	Compliance	Description	Data
N/A	Ramp Length (in)	39.0	Yes	BlendTrans Slope (%)	1.2
No	Ramp Width (in)	44.0	Yes	BlendTrans XSlope (%)	0.1
N/A	Flare Type LT	N/A	N/A	Flare Type RT	N/A
N/A	Flare Slope LT (%)	N/A	N/A	Flare Slope RT (%)	N/A
N/A	Flare Traversable LT?	N/A	N/A	Flare Traversable RT?	N/A
N/A	Landing Length (in)	N/A	N/A	DWS Provided?	N/A
N/A	Landing Width (in)	N/A	N/A	DWS Contrast?	N/A
N/A	Landing Slope (%)	N/A	N/A	DWS Length (in)	N/A
N/A	Landing X Slope (%)	N/A	N/A	DWS Full Width?	N/A
N/A	Landing Curb? (Y/N)	N/A	N/A	DWS Offset (in)	N/A
N/A	Shared Landing?	N/A			
N/A	Gutter Ponding?	N/A	N/A	Gutter Slope (%)	N/A
N/A	Gutter Lip Ht (in)	N/A	N/A	Gutter X Slope (%)	N/A
N/A	Painted X Walk1?	Yes	N/A	Painted X Walk2?	No
	X Walk 1 Direction	To S		X Walk 2 Direction	To E
	X Walk 1 Width (in)	95.0		X Walk 2 Width (in)	N/A
	X Walk 1 Slope (%)	1.2		X Walk 2 Slope (%)	0.2
	X Walk 1 X Slope (%)	2.1		X Walk 2 X Slope (%)	2.1

N/A	Ramp inside XWalk1?	Yes	N/A	Ramp inside XWalk2?	N/A
	Road Slope (%)	1.1		Clear Space?	N/A
	Road X Slope (%)	1.6	N/A	Clear Space to XWalk (in)	N/A
N/A	Any Obstructions?	N/A	N/A	Storm Grate/Utility Hazard?	N/A
	Obstruction Type			Storm Grate/Utility Type	
		N/A			N/A
			Yes	Surface Condition? (G/P)	Good
			No	Curb Slope (%)	8.6

**Remove & Replace Curb Ramp With Two New Directional Ramps or Equivalent.**

Total Cost: \$ 3200.00
