# Access Compliance Report

## Public Rights-of-Way

### (Curb Ramps)

| Intersection ID: 11727 | Main Street: W_8TH_ST | Cross Street: N_POPLAR_ST | Location: S |

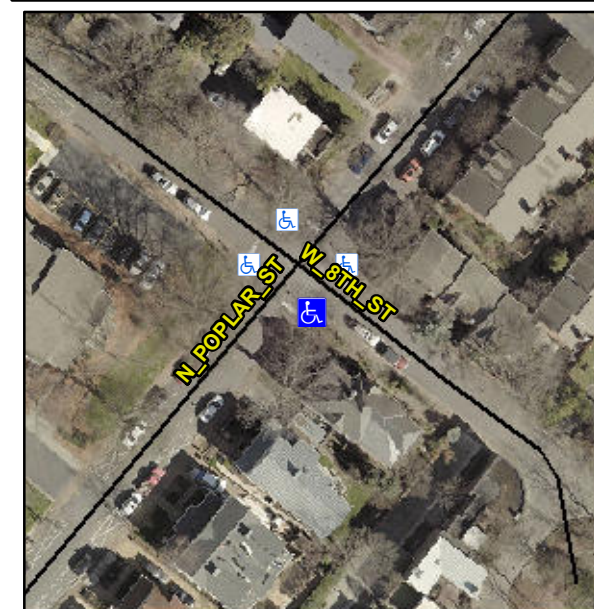
| ADA ID: 2D04E93C43DA | Ramp Type: PerpDiag | Initial Pass/Fail: Fail | Overall Compliance: No |
| Severity Score: 13.75 | | | |

**Not Found, R304.2.2, R304.5.3**

| Compliance | Description | Data | Compliance | Description | Data |
|---|---|---|---|---|---|
| N/A | Ramp Length (in) | 31.0 | No | Ramp Slope (%) | 11.4 |
| Yes | Ramp Width (in) | 48.0 | No | Ramp XSlope (%) | 3.2 |

**Remove & Replace Curb Ramp With Two New Directional Ramps or Equivalent.**

Total Cost: \$ 3200.00
