Access Compliance Report

Public Rights-of-Way

(Curb Ramps)

Intersection ID: 29992	Main Street: REIGATE_RD	Cross Street: KEMPSFORD_DR	Location: E
ADA ID: 2D055E83FFE2	Ramp Type: PerpDiag	Initial Pass/Fail: Fail	Overall Compliance: No
Severity Score: 8.75			
Codes/Mitigation Info/Possible Solution		Field Measurements/Component Compliance

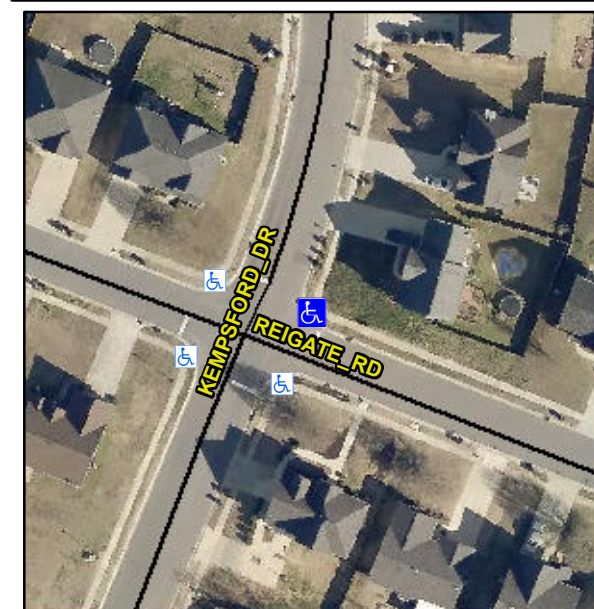
Not Found, R304.5.1

Compliance	Description	Data	Compliance	Description	Data
N/A	Ramp Length (in)	49.0	Yes	Ramp Slope (%)	7.9
No	Ramp Width (in)	42.0	Yes	Ramp XSlope (%)	1.9
N/A	Flare Type LT	N/A	N/A	Flare Type RT	N/A
N/A	Flare Slope LT (%)	N/A	N/A	Flare Slope RT (%)	N/A
N/A	Flare Traversable LT?	N/A	N/A	Flare Traversable RT?	N/A
N/A	Landing Length (in)	N/A	N/A	DWS Provided?	N/A
N/A	Landing Width (in)	N/A	N/A	DWS Contrast?	N/A
N/A	Landing Slope (%)	N/A	N/A	DWS Length (in)	N/A
N/A	Landing X Slope (%)	N/A	N/A	DWS Full Width?	N/A
N/A	Landing Curb? (Y/N)	N/A	N/A	DWS Offset (in)	N/A
N/A	Shared Landing?	N/A			
N/A	Gutter Ponding?	N/A	N/A	Gutter Slope (%)	N/A
N/A	Gutter Lip Ht (in)	N/A	N/A	Gutter X Slope (%)	N/A
N/A	Painted X Walk1?	No	N/A	Painted X Walk2?	No
	X Walk 1 Direction	To NW		X Walk 2 Direction	To SW
N/A	X Walk 1 Width (in)	N/A	N/A	X Walk 2 Width (in)	N/A
	X Walk 1 Slope (%)	0.7		X Walk 2 Slope (%)	1.4
	X Walk 1 X Slope (%)	1.8		X Walk 2 X Slope (%)	1.0

N/A	Ramp inside XWalk1?	N/A	N/A	Ramp inside XWalk2?	N/A
	Road Slope (%)	2.4	N/A	Clear Space?	N/A
	Road X Slope (%)	1.6	N/A	Clear Space to XWalk (in)	N/A
N/A	Any Obstructions?	N/A	N/A	Storm Grate/Utility Hazard?	N/A
	Obstruction Type			Storm Grate/Utility Type	
		N/A			N/A
		Yes		Surface Condition? (G/P)	Good

Remove & Replace Curb Ramp With Two New Directional Ramps or Equivalent.
