# Access Compliance Report

## Public Rights-of-Way

### (Curb Ramps)

Intersection ID: N/A	Main Street: NINA_DR	Cross Street: W_T_HARRIS_BV	Location: NW
ADA ID: 2D0DDEE6D565	Ramp Type: Para	Initial Pass/Fail: Fail	Overall Compliance: No
Severity Score: 13.75			
Codes/Mitigation Info/Possible Solution		Field Measurements/Component Compliance

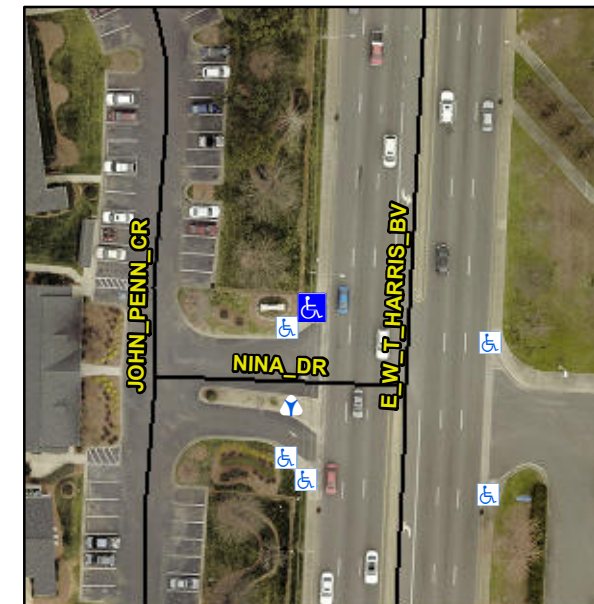
**MEDIAN ACROSS W T HARRIS BV**

**R304.3.2, R304.5.3**

Compliance	Description	Data	Compliance	Description	Data
N/A	Ramp Length LT (in)	63.0	N/A	Ramp Length RT (in)	62.5
Yes	Ramp Width LT (in)	59.0	Yes	Ramp Width RT (in)	60.0
Yes	Ramp Slope LT (%)	7.4	No	Ramp Slope RT (%)	9.8
Yes	Ramp XSlope LT (%)	0.5	No	Ramp XSlope RT (%)	2.6
N/A	Landing Length (in)	N/A	N/A	DWS Provided?	N/A
N/A	Landing Width (in)	N/A	N/A	DWS Contrast?	N/A
N/A	Landing Slope (%)	N/A	N/A	DWS Length (in)	N/A
N/A	Landing X Slope (%)	N/A	N/A	DWS Full Width?	N/A
N/A	Landing Curb? (Y/N)	N/A	N/A	DWS Offset (in)	N/A
N/A	Shared Landing?	N/A			
N/A	Gutter Ponding?	N/A	N/A	Gutter Slope (%)	N/A
N/A	Gutter Lip Ht (in)	N/A	N/A	Gutter X Slope (%)	N/A
N/A	Painted X Walk1?	No	N/A	Painted X Walk2?	N/A
	X Walk 1 Direction	To E		X Walk 2 Direction	N/A
N/A	X Walk 1 Width (in)	N/A	N/A	X Walk 2 Width (in)	N/A
	X Walk 1 Slope (%)	0.6		X Walk 2 Slope (%)	N/A
	X Walk 1 X Slope (%)	1.0		X Walk 2 X Slope (%)	N/A
N/A	Ramp inside XWalk1?	N/A	N/A	Ramp inside XWalk2?	N/A

Road Slope (%)	N/A	N/A	Clear Space?	N/A
	Road X Slope (%)	N/A	N/A	Clear Space to XWalk (in)	N/A
N/A	Any Obstructions?	N/A	N/A	Storm Grate/Utility Hazard?	N/A
	Obstruction Type			Storm Grate/Utility Type	
		N/A			N/A
			Yes	Surface Condition? (G/P)	Good
			N/A	Curb Slope (%)	2.3

**Remove & Replace Entire Ramp.**
