Access Compliance Report Public Rights-of-Way (Curb Ramps)

Intersection ID: 10025500 Main Street: E_MARTIN_LUTHER_KING_JR_OBVss Street: N/A Location: S

Ramp Type: Directional1 **Overall Compliance: No** 25 ADA ID: 2D108462FE62 Initial Pass/Fail: Fail **Severity Score:**

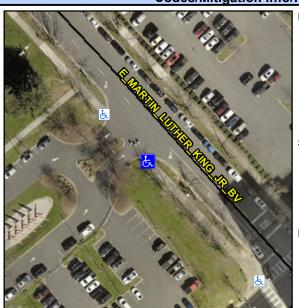
Field Measurements/Component Compliance								
Comp	liance Description	Data	Comp	liance Description	Data			
N/A	Ramp Length (in)	80.0	N/A	Grade Break?	N/A			
Yes	Ramp Width (in)	95.0	N/A	Grade Break Slope (%)	0.0			
Yes	Ramp Slope (%)	1.2	N/A	Grade Break XSlope (%)	0.0			
No	Ramp XSlope (%)	7.6						
N/A	Flare Type LT	N/A	N/A	Flare Type RT	N/A			
N/A	Flare Slope LT (%)	N/A	N/A	Flare Slope RT (%)	0.0			
N/A	Flare Traversable LT?	N/A	N/A	Flare Traversable RT?	N/A			
N/A	Landing Length (in)	0.0	N/A	DWS Provided?	N/A			
N/A	Landing Width (in)	0.0	N/A	DWS Contrast?	N/A			
N/A	Landing Slope (%)	0.0	N/A	DWS Length (in)	N/A			
N/A	Landing X Slope (%)	0.0	N/A	DWS Full Width?	N/A			
N/A	Landing Curb? (Y/N)	N/A	N/A	DWS Offset LT (in)	N/A			
N/A	Shared Landing?	N/A	N/A	DWS Offset RT (in)	N/A			
N/A	Gutter Ponding?	0.0	N/A	Gutter Slope (%)	N/A			
N/A	Gutter Lip Ht (in)	0.0	N/A	Gutter X Slope (%)	N/A			
N/A	Painted X Walk1?	No		Road Slope (%)	4.6

X Walk 1 Direction	To NW		Road X Slope (%)	7.6			
	X Walk 1 Width (in)	N/A		Clear Space?	N/A			
	X Walk 1 Slope (%)	4.6	N/A	Clear Space to XWalk (in)	N/A			
	X Walk 1 X Slope (%)	7.6	N/A	Storm Grate/Utility Hazard?	N/A			
N/A	Ramp inside XWalk1?	N/A		Storm Grate/Utility Type				
N/A	Any Obstructions?	N/A			N/A			
	Obstruction Type		Yes	Surface Condition? (G/P)	Good			
		N/A	N/A	Curb Slope (%)	8.3			
			=

Possible Solutions:
	Remove & Replace Entire Ramp.
ı	
ı	
-	
•	
	Surveyor Notes:
	N/A
ì	
4	PROW/ADA:
ξ	R304.5.3
4

Total Cost:	\$ 1600.00
