# Access Compliance Report

## Public Rights-of-Way

| Intersection ID: 3806 | Main Street: BRIARCREST_CT | Cross Street: CHESTNUT_KNOLL_LN | Location: S |
| ADA ID: 2D1363DFF995 | Ramp Type: Perp | Initial Pass/Fail: Fail | Overall Compliance: No |

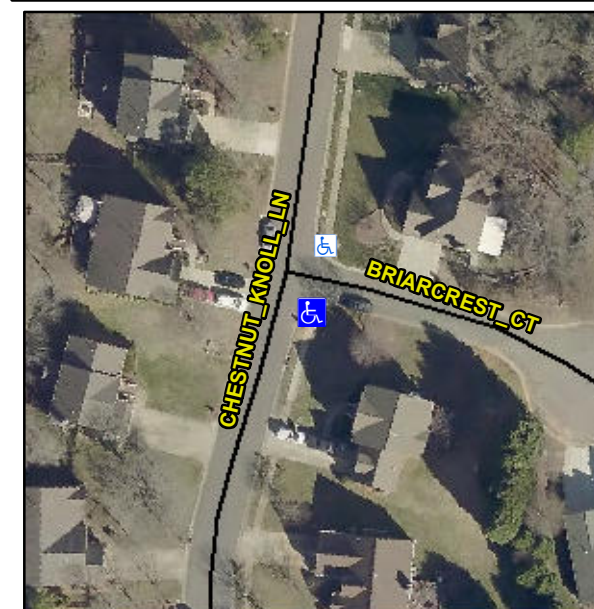
**Not Found, R304.5.1, R304.5.3**

| Compliance | Description | Data | Compliance | Description | Data |
|---|---|---|---|---|---|
| N/A | Ramp Length (in) | 50.0 | Yes | Ramp Slope (%) | 7.9 |
| No | Ramp Width (in) | 47.5 | No | Ramp XSlope (%) | 12.8 |

**Remove & Replace Entire Ramp.**

Total Cost: \$ 1850.00

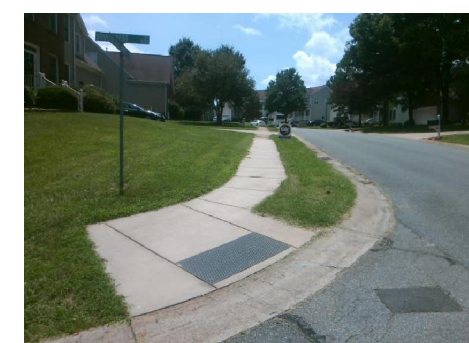
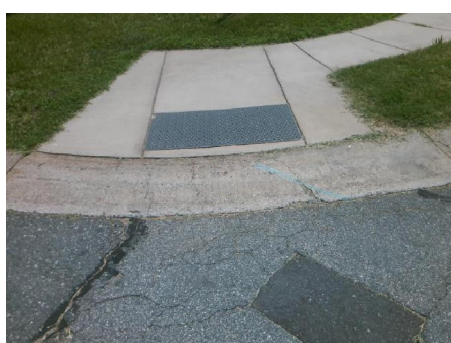
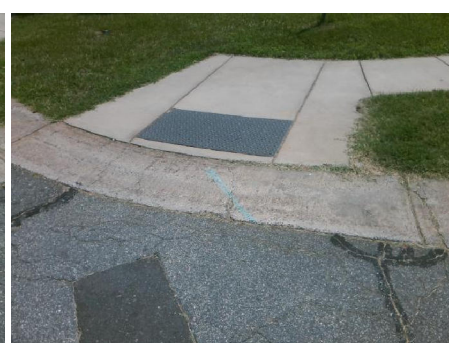
| Compliance | Description | Data | Compliance | Description | Data |
|---|---|---|---|---|---|
| | | | Yes | Surface Condition? (G/P) | Good |
