Access Compliance Report

Public Rights-of-Way

(Curb Ramps)

Intersection ID: 11483	Main Street: E_17TH_ST	Cross Street: N_CALDWELL_ST	Location: E
ADA ID: 2D16E00FBF1C	Ramp Type: PerpDiag	Initial Pass/Fail: Fail	Overall Compliance: No
Severity Score: 12.5			
Codes/Mitigation Info/Possible Solution		Field Measurements/Component Compliance

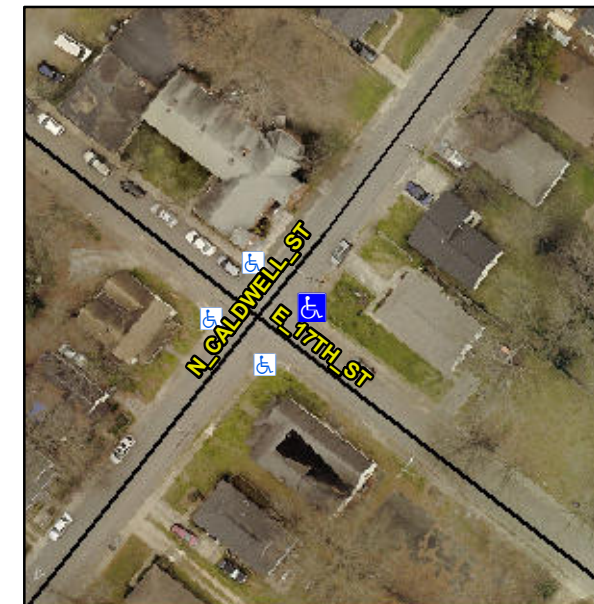
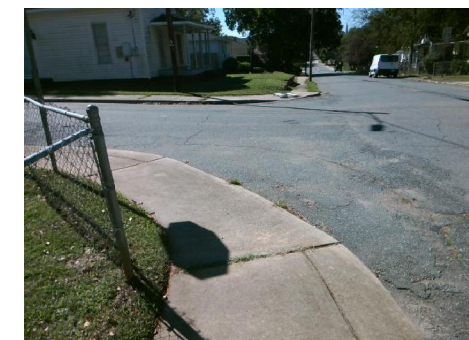
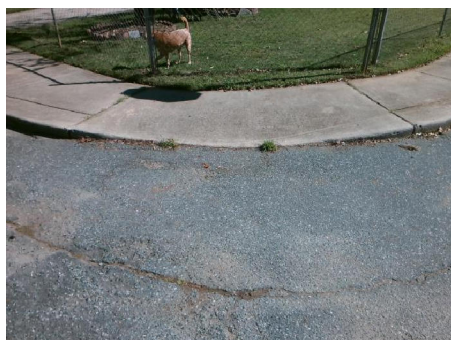
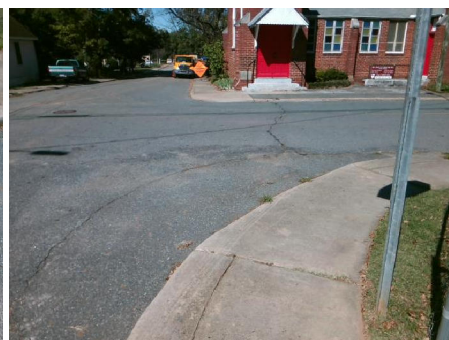
Not Found, R304.2.2

Compliance	Description	Data	Compliance	Description	Data
N/A	Ramp Length (in)	52.0	No	Ramp Slope (%)	10.0
Yes	Ramp Width (in)	60.0	Yes	Ramp XSlope (%)	1.1
N/A	Flare Type LT	N/A	N/A	Flare Type RT	N/A
N/A	Flare Slope LT (%)	N/A	N/A	Flare Slope RT (%)	N/A
N/A	Flare Traversable LT?	N/A	N/A	Flare Traversable RT?	N/A
N/A	Landing Length (in)	N/A	N/A	DWS Provided?	N/A
N/A	Landing Width (in)	N/A	N/A	DWS Contrast?	N/A
N/A	Landing Slope (%)	N/A	N/A	DWS Length (in)	N/A
N/A	Landing X Slope (%)	N/A	N/A	DWS Full Width?	N/A
N/A	Landing Curb? (Y/N)	N/A	N/A	DWS Offset (in)	N/A
N/A	Shared Landing?	N/A			
N/A	Gutter Ponding?	N/A	N/A	Gutter Slope (%)	N/A
N/A	Gutter Lip Ht (in)	N/A	N/A	Gutter X Slope (%)	N/A
N/A	Painted X Walk1?	No	N/A	Painted X Walk2?	No
	X Walk 1 Direction	To NW		X Walk 2 Direction	To SW
N/A	X Walk 1 Width (in)	N/A	N/A	X Walk 2 Width (in)	N/A
	X Walk 1 Slope (%)	1.5		X Walk 2 Slope (%)	0.1
	X Walk 1 X Slope (%)	1.9		X Walk 2 X Slope (%)	0.7

N/A	Ramp inside XWalk1?	N/A	N/A	Ramp inside XWalk2?	N/A
	Road Slope (%)	1.2	N/A	Clear Space?	N/A
	Road X Slope (%)	1.6	N/A	Clear Space to XWalk (in)	N/A
N/A	Any Obstructions?	N/A	N/A	Storm Grate/Utility Hazard?	N/A
	Obstruction Type			Storm Grate/Utility Type	
		N/A			N/A
		Yes		Surface Condition? (G/P)	Good

Remove & Replace Curb Ramp With Two New Directional Ramps or Equivalent.
