Access Compliance Report

Public Rights-of-Way

(Curb Ramps)

Intersection ID: 19029	Main Street: SHARON_LN	Cross Street: FOXCROFT_RD	Location: NW
ADA ID: 2D18F2B55658	Ramp Type: PerpDiag	Initial Pass/Fail: Fail	Overall Compliance: No
Severity Score: 33.75			
Codes/Mitigation Info/Possible Solution		Field Measurements/Component Compliance

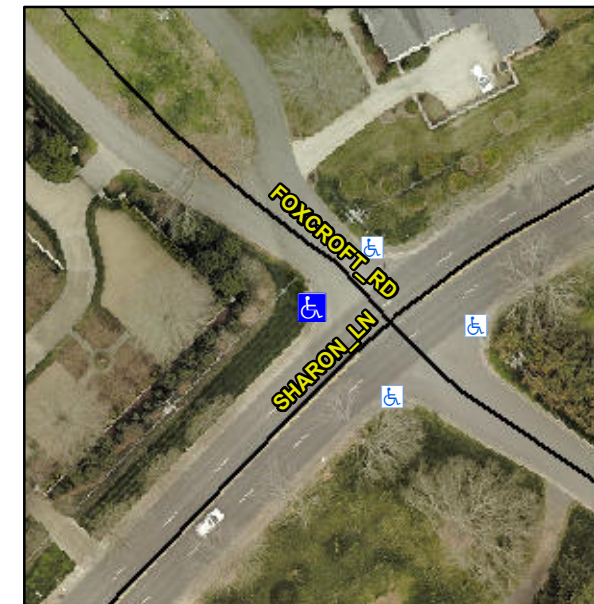
Compliance	Description	Data	Compliance	Description	Data
N/A	Ramp Length (in)	50.0	Yes	Ramp Slope (%)	8.3
No	Ramp Width (in)	37.0	No	Ramp XSlope (%)	8.0
N/A	Flare Type LT	N/A	N/A	Flare Type RT	N/A
N/A	Flare Slope LT (%)	N/A	N/A	Flare Slope RT (%)	N/A
N/A	Flare Traversable LT?	N/A	N/A	Flare Traversable RT?	N/A
N/A	Landing Length (in)	N/A	N/A	DWS Provided?	N/A
N/A	Landing Width (in)	N/A	N/A	DWS Contrast?	N/A
N/A	Landing Slope (%)	N/A	N/A	DWS Length (in)	N/A
N/A	Landing X Slope (%)	N/A	N/A	DWS Full Width?	N/A
N/A	Landing Curb? (Y/N)	N/A	N/A	DWS Offset (in)	N/A
N/A	Shared Landing?	N/A			
N/A	Gutter Ponding?	N/A	N/A	Gutter Slope (%)	N/A
N/A	Gutter Lip Ht (in)	N/A	N/A	Gutter X Slope (%)	N/A
N/A	Painted X Walk1?	No	N/A	Painted X Walk2?	No
	X Walk 1 Direction	To SE		X Walk 2 Direction	To NE
N/A	X Walk 1 Width (in)	N/A	N/A	X Walk 2 Width (in)	N/A
	X Walk 1 Slope (%)	7.5		X Walk 2 Slope (%)	2.5
	X Walk 1 X Slope (%)	0.9		X Walk 2 X Slope (%)	5.5

N/A	Ramp inside XWalk1?	N/A	N/A	Ramp inside XWalk2?	N/A
	Road Slope (%)	6.6	N/A	Clear Space?	N/A
	Road X Slope (%)	5.0	N/A	Clear Space to XWalk (in)	N/A
N/A	Any Obstructions?	N/A	N/A	Storm Grate/Utility Hazard?	N/A
	Obstruction Type			Storm Grate/Utility Type	
		N/A			N/A
		Yes		Surface Condition? (G/P)	Good

Possible Solutions:

Remove & Replace Curb Ramp With Two New Directional Ramps or Equivalent.

R304.5.1, R304.5.3
