# Access Compliance Report

## Public Rights-of-Way

### (Curb Ramps)

| Intersection ID: 27872 | Main Street: BALLANTYNE_COUNTRY_CLUB_DR | Cross Street: LETHCO_WY | Location: S |

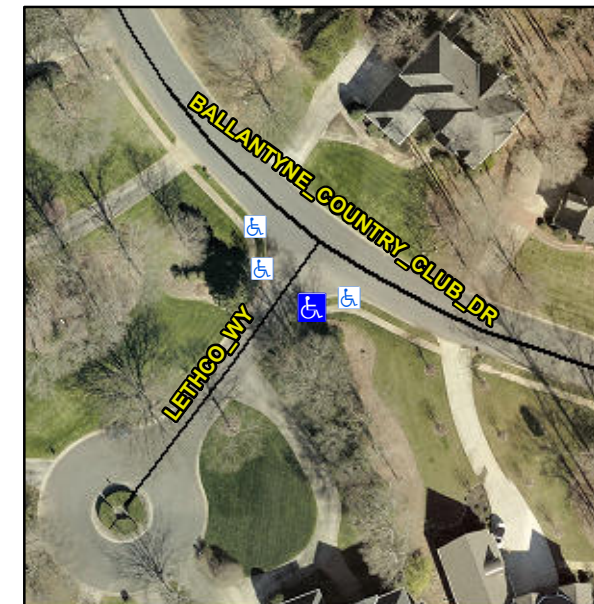
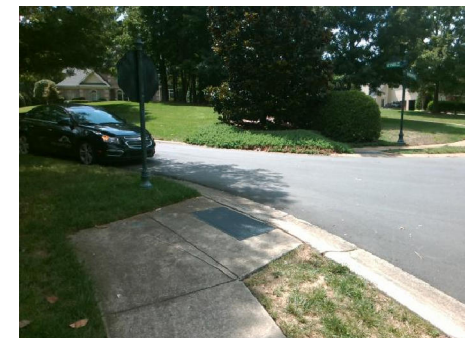
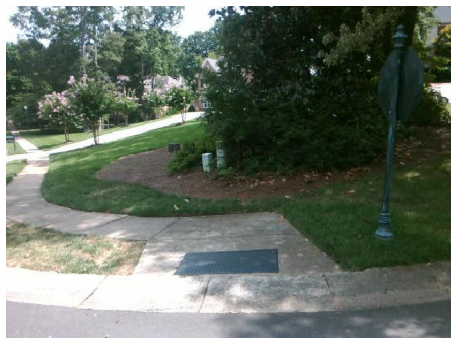
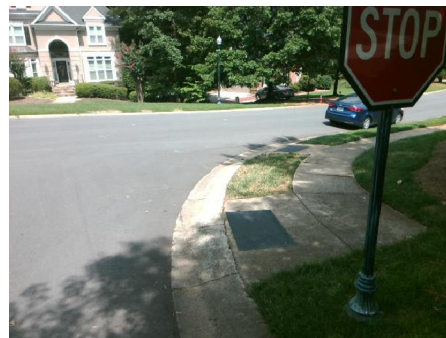
| ADA ID: 2D1995C777D7 | Ramp Type: BlendTrans2 | Initial Pass/Fail: Fail | Overall Compliance: No |

**Not Found, R304.5.3**

| Compliance | Description | Data | Compliance | Description | Data |
|---|---|---|---|---|---|
| Yes | Ramp Width (in) | 48.0 | No | BlendTrans XSlope (%) | 9.5 |
| | | | No | Curb Slope (%) | 15.0 |

**Remove & Replace Curb Ramp With Two New Directional Ramps or Equivalent.**

Total Cost: \$ 3200.00
