Access Compliance Report

Public Rights-of-Way

(Curb Ramps)

Intersection ID: 49796	Main Street: TRISTAN_CT	Cross Street: ATKINS_RIDGE_DR	Location: S
ADA ID: 2D2092CE4115	Ramp Type: PerpDiag	Initial Pass/Fail: Fail	Overall Compliance: No
Severity Score: 0			
Codes/Mitigation Info/Possible Solution		Field Measurements/Component Compliance

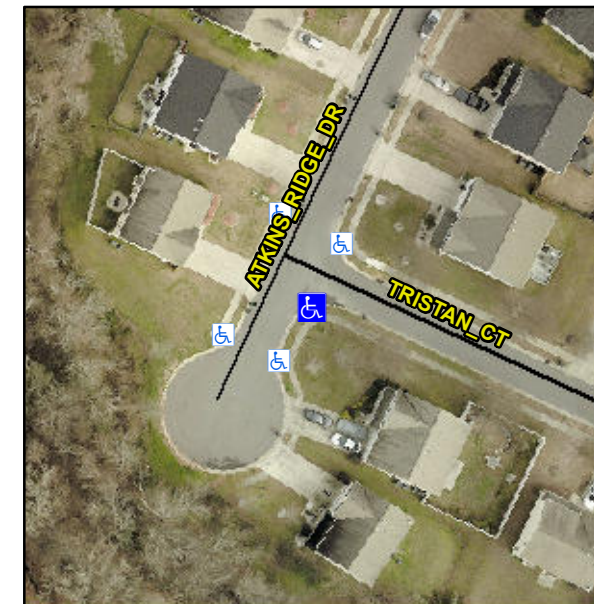
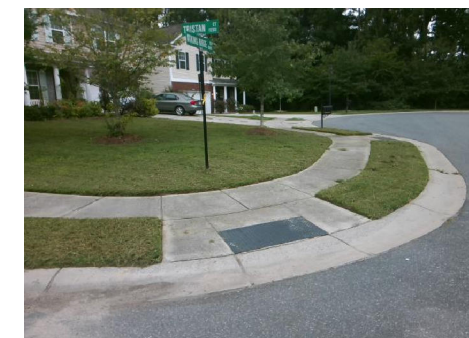
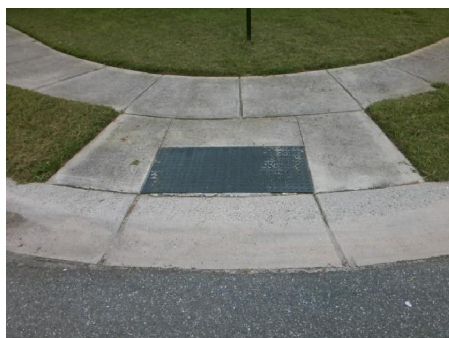
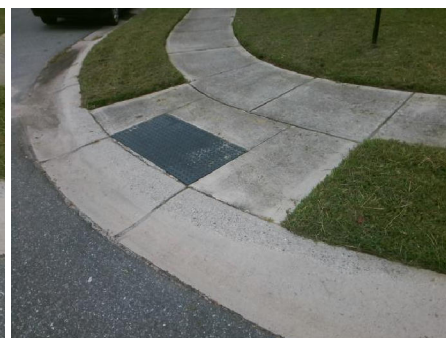
Compliance	Description	Data	Compliance	Description	Data
N/A	Ramp Length (in)	47.0	Yes	Ramp Slope (%)	7.6
Yes	Ramp Width (in)	48.1	Yes	Ramp XSlope (%)	2.0
N/A	Flare Type LT	N/A	N/A	Flare Type RT	N/A
N/A	Flare Slope LT (%)	N/A	N/A	Flare Slope RT (%)	N/A
N/A	Flare Traversable LT?	N/A	N/A	Flare Traversable RT?	N/A
N/A	Landing Length (in)	N/A	N/A	DWS Provided?	N/A
N/A	Landing Width (in)	N/A	N/A	DWS Contrast?	N/A
N/A	Landing Slope (%)	N/A	N/A	DWS Length (in)	N/A
N/A	Landing X Slope (%)	N/A	N/A	DWS Full Width?	N/A
N/A	Landing Curb? (Y/N)	N/A	N/A	DWS Offset (in)	N/A
N/A	Shared Landing?	N/A			
N/A	Gutter Ponding?	N/A	N/A	Gutter Slope (%)	N/A
N/A	Gutter Lip Ht (in)	N/A	N/A	Gutter X Slope (%)	N/A
N/A	Painted X Walk1?	No	N/A	Painted X Walk2?	No
	X Walk 1 Direction	To NE		X Walk 2 Direction	To NW
N/A	X Walk 1 Width (in)	N/A	N/A	X Walk 2 Width (in)	N/A
	X Walk 1 Slope (%)	0.2		X Walk 2 Slope (%)	1.5
	X Walk 1 X Slope (%)	0.4		X Walk 2 X Slope (%)	0.8

N/A	Ramp inside XWalk1?	N/A	N/A	Ramp inside XWalk2?	N/A
	Road Slope (%)	1.1	N/A	Clear Space?	N/A
	Road X Slope (%)	0.1	N/A	Clear Space to XWalk (in)	N/A
N/A	Any Obstructions?	N/A	N/A	Storm Grate/Utility Hazard?	N/A
	Obstruction Type			Storm Grate/Utility Type	
		N/A			N/A
			Yes	Surface Condition? (G/P)	Good

Remove & Replace Curb Ramp With Two New Directional Ramps or Equivalent.
