Access Compliance Report Public Rights-of-Way (Curb Ramps)

Intersection ID: 10034966Main Street:PROVIDENCE_RD_WESTCross Street: N/ALocation:NWADA ID: 2D252403E056Ramp Type:Directional1Initial Pass/Fail: FailOverall Compliance: NoSeverity Score:12.5

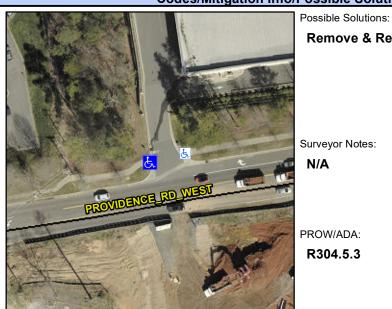
Comp	liance Description	Data	Comp	oliance Description	Data
N/A	Ramp Length (in)	109.0	N/A	Grade Break?	N/A
Yes	Ramp Width (in)	69.0	N/A	Grade Break Slope (%)	0.0
Yes	Ramp Slope (%)	1.2	N/A	Grade Break XSlope (%)	0.0
No	Ramp XSlope (%)	5.4			
N/A	Flare Type LT	N/A	N/A	Flare Type RT	N/A
N/A	Flare Slope LT (%)	N/A	N/A	Flare Slope RT (%)	0.0
N/A	Flare Traversable LT?	N/A	N/A	Flare Traversable RT?	N/A
N/A	Landing Length (in)	0.0	N/A	DWS Provided?	N/A
N/A	Landing Width (in)	0.0	N/A	DWS Contrast?	N/A
N/A	Landing Slope (%)	0.0	N/A	DWS Length (in)	N/A
N/A	Landing X Slope (%)	0.0	N/A	DWS Full Width?	N/A
N/A	Landing Curb? (Y/N)	N/A	N/A	DWS Offset LT (in)	N/A
N/A	Shared Landing?	N/A	N/A	DWS Offset RT (in)	N/A
N/A	Gutter Ponding?	0.0	N/A	Gutter Slope (%)	N/A
N/A	Gutter Lip Ht (in)	0.0	N/A	Gutter X Slope (%)	N/A
N/A	Painted X Walk1?	No		Road Slope (%)	0.7
	X Walk 1 Direction	To NE		Road X Slope (%)	3.4
	X Walk 1 Width (in)	N/A	l	Clear Space?	N/A

X Walk 1 Slope (%)	0.7	N/A	Clear Space to XWalk (in)	N/A
	X Walk 1 X Slope (%)	3.4	N/A	Storm Grate/Utility Hazard?	N/A
N/A	Ramp inside XWalk1?	N/A		Storm Grate/Utility Type	
N/A	Any Obstructions?	N/A			N/A
	Obstruction Type		Yes	Surface Condition? (G/P)	Good
		N/A	N/A	Curb Slope (%)	0.5

1 ossible colutions.				
Remove & Replace Entire Ramp.				
Surveyor Notes:				
N/A				
PROW/ADA:				
R304.5.3				
100-11010
