# Access Compliance Report

## Public Rights-of-Way

### (Curb Ramps)

Intersection ID: 12333	Main Street: N_BREVARD_ST	Cross Street: E_7TH_ST	Location: N
ADA ID: 2D2621C7B67E	Ramp Type: Perp	Initial Pass/Fail: Fail	Overall Compliance: No
Severity Score: 13.75			
Codes/Mitigation Info/Possible Solution		Field Measurements/Component Compliance

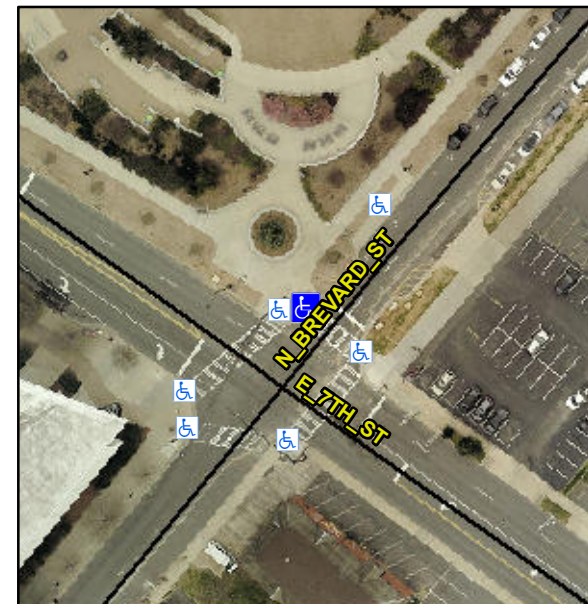
Compliance	Description	Data	Compliance	Description	Data
N/A	Ramp Length (in)	70.0	No	Ramp Slope (%)	8.5
Yes	Ramp Width (in)	48.0	Yes	Ramp XSlope (%)	4.2
N/A	Flare Type LT	N/A	N/A	Flare Type RT	N/A
N/A	Flare Slope LT (%)	N/A	N/A	Flare Slope RT (%)	N/A
N/A	Flare Traversable LT?	N/A	N/A	Flare Traversable RT?	N/A
N/A	Landing Length (in)	N/A	N/A	DWS Provided?	N/A
N/A	Landing Width (in)	N/A	N/A	DWS Contrast?	N/A
N/A	Landing Slope (%)	N/A	N/A	DWS Length (in)	N/A
N/A	Landing X Slope (%)	N/A	N/A	DWS Full Width?	N/A
N/A	Landing Curb? (Y/N)	N/A	N/A	DWS Offset (in)	N/A
N/A	Shared Landing?	N/A			
N/A	Gutter Ponding?	N/A	N/A	Gutter Slope (%)	N/A
N/A	Gutter Lip Ht (in)	N/A	N/A	Gutter X Slope (%)	N/A
N/A	Painted X Walk1?	Yes	N/A	Painted X Walk2?	N/A
	X Walk 1 Direction	To SE		X Walk 2 Direction	N/A
N/A	X Walk 1 Width (in)	112.0	N/A	X Walk 2 Width (in)	N/A
	X Walk 1 Slope (%)	0.6		X Walk 2 Slope (%)	N/A
	X Walk 1 X Slope (%)	4.2		X Walk 2 X Slope (%)	N/A

N/A	Ramp inside XWalk1?	Yes	N/A	Ramp inside XWalk2?	N/A
	Road Slope (%)	N/A	N/A	Clear Space?	N/A
	Road X Slope (%)	N/A	N/A	Clear Space to XWalk (in)	N/A
N/A	Any Obstructions?	N/A	N/A	Storm Grate/Utility Hazard?	N/A
	Obstruction Type			Storm Grate/Utility Type	
		N/A			N/A
		Yes		Surface Condition? (G/P)	Good

Possible Solutions:

**Remove & Replace Entire Ramp.**

**R304.2.2**

**\$ 1850.00**
