Access Compliance Report

Public Rights-of-Way

(Curb Ramps)

Intersection ID: 15838	Main Street: POWDER_HORN_RD	Cross Street: RIDING_TRAIL_RD	Location: SE
ADA ID: 2D2AF965A30D	Ramp Type: PerpDiag	Initial Pass/Fail: Fail	Overall Compliance: No
		Severity Score: 37.5

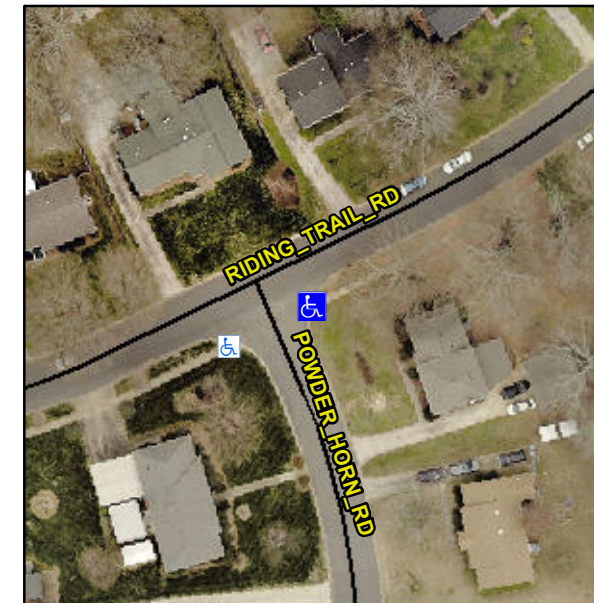
Not Found, R304.2.2, R304.5.3

Compliance	Description	Data	Compliance	Description	Data
N/A	Ramp Length (in)	43.0	No	Ramp Slope (%)	11.3
Yes	Ramp Width (in)	48.0	No	Ramp XSlope (%)	9.4
N/A	Flare Type LT	N/A	N/A	Flare Type RT	N/A
N/A	Flare Slope LT (%)	N/A	N/A	Flare Slope RT (%)	N/A
N/A	Flare Traversable LT?	N/A	N/A	Flare Traversable RT?	N/A
N/A	Landing Length (in)	N/A	N/A	DWS Provided?	N/A
N/A	Landing Width (in)	N/A	N/A	DWS Contrast?	N/A
N/A	Landing Slope (%)	N/A	N/A	DWS Length (in)	N/A
N/A	Landing X Slope (%)	N/A	N/A	DWS Full Width?	N/A
N/A	Landing Curb? (Y/N)	N/A	N/A	DWS Offset (in)	N/A
N/A	Shared Landing?	N/A			
N/A	Gutter Ponding?	N/A	N/A	Gutter Slope (%)	N/A
N/A	Gutter Lip Ht (in)	N/A	N/A	Gutter X Slope (%)	N/A
N/A	Painted X Walk1?	No	N/A	Painted X Walk2?	No
	X Walk 1 Direction	To NW		X Walk 2 Direction	To SW
N/A	X Walk 1 Width (in)	N/A	N/A	X Walk 2 Width (in)	N/A
	X Walk 1 Slope (%)	6.1		X Walk 2 Slope (%)	5.8
	X Walk 1 X Slope (%)	6.0		X Walk 2 X Slope (%)	7.3

Possible Solutions:

Remove & Replace Curb Ramp With Two New Directional Ramps or Equivalent.
