Access Compliance Report

Public Rights-of-Way

(Curb Ramps)

Intersection ID: 44005	Main Street: ARCOLA_LN	Cross Street: ELROSE_PL	Location: NE
ADA ID: 2D31E6247A59	Ramp Type: Perp	Initial Pass/Fail: Fail	Overall Compliance: No
Severity Score: 47.5			
Codes/Mitigation Info/Possible Solution		Field Measurements/Component Compliance

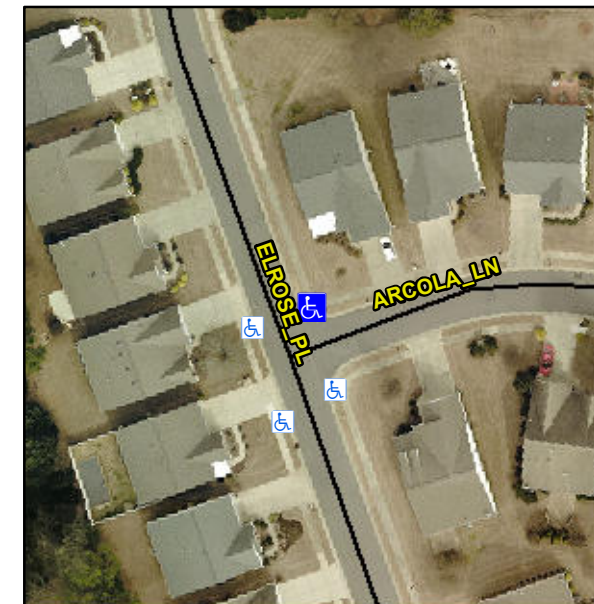
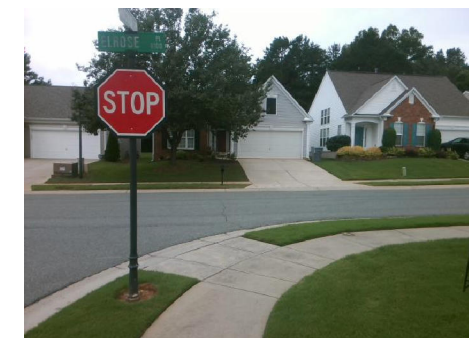
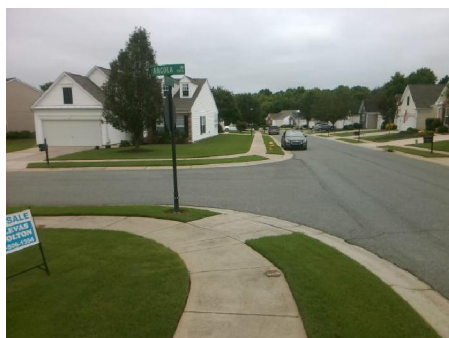
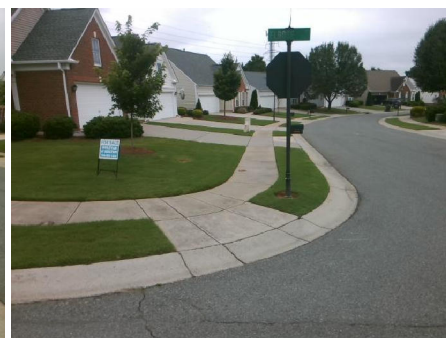
Not Found, R304.5.1, R304.5.3

Compliance	Description	Data	Compliance	Description	Data
N/A	Ramp Length (in)	95.0	Yes	Ramp Slope (%)	4.7
No	Ramp Width (in)	25.0	No	Ramp XSlope (%)	6.1
N/A	Flare Type LT	N/A	N/A	Flare Type RT	N/A
N/A	Flare Slope LT (%)	N/A	N/A	Flare Slope RT (%)	N/A
N/A	Flare Traversable LT?	N/A	N/A	Flare Traversable RT?	N/A
N/A	Landing Length (in)	N/A	N/A	DWS Provided?	N/A
N/A	Landing Width (in)	N/A	N/A	DWS Contrast?	N/A
N/A	Landing Slope (%)	N/A	N/A	DWS Length (in)	N/A
N/A	Landing X Slope (%)	N/A	N/A	DWS Full Width?	N/A
N/A	Landing Curb? (Y/N)	N/A	N/A	DWS Offset (in)	N/A
N/A	Shared Landing?	N/A			
N/A	Gutter Ponding?	N/A	N/A	Gutter Slope (%)	N/A
N/A	Gutter Lip Ht (in)	N/A	N/A	Gutter X Slope (%)	N/A
N/A	Painted X Walk1?	No	N/A	Painted X Walk2?	N/A
	X Walk 1 Direction	To S		X Walk 2 Direction	N/A
N/A	X Walk 1 Width (in)	N/A	N/A	X Walk 2 Width (in)	N/A
	X Walk 1 Slope (%)	3.8		X Walk 2 Slope (%)	N/A
	X Walk 1 X Slope (%)	4.4		X Walk 2 X Slope (%)	N/A

Remove & Replace Entire Ramp.
