Access Compliance Report

Public Rights-of-Way

(Curb Ramps)

Intersection ID: 28251	Main Street: PEMSWOOD_ST	Cross Street: SUMMER CLUB_RD	Location: NE
ADA ID: 2D44CD6C4990	Ramp Type: BlendTrans2	Initial Pass/Fail: Fail	Overall Compliance: No
		Severity Score: 12.5

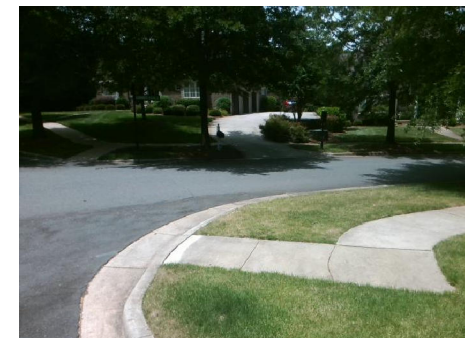
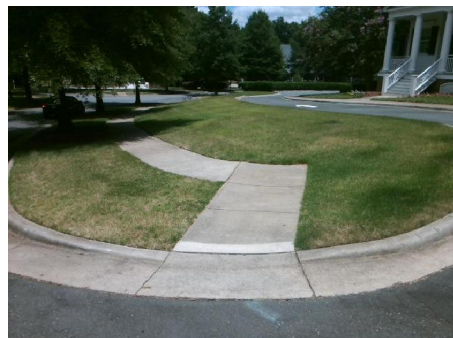
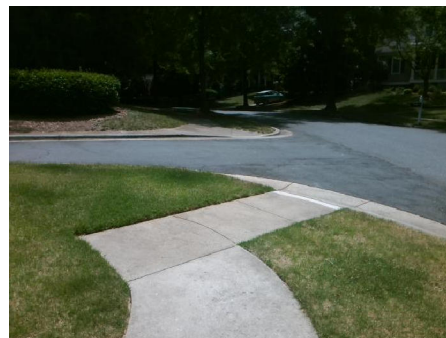
Not Found, R304.5.3

Compliance	Description	Data	Compliance	Description	Data
N/A	Ramp Length (in)	142.0	Yes	BlendTrans Slope (%)	0.9
Yes	Ramp Width (in)	51.5	No	BlendTrans XSlope (%)	5.1
N/A	Flare Type LT	N/A	N/A	Flare Type RT	N/A
N/A	Flare Slope LT (%)	N/A	N/A	Flare Slope RT (%)	N/A
N/A	Flare Traversable LT?	N/A	N/A	Flare Traversable RT?	N/A
N/A	Landing Length (in)	N/A	N/A	DWS Provided?	N/A
N/A	Landing Width (in)	N/A	N/A	DWS Contrast?	N/A
N/A	Landing Slope (%)	N/A	N/A	DWS Length (in)	N/A
N/A	Landing X Slope (%)	N/A	N/A	DWS Full Width?	N/A
N/A	Landing Curb? (Y/N)	N/A	N/A	DWS Offset (in)	N/A
N/A	Shared Landing?	N/A			
N/A	Gutter Ponding?	N/A	N/A	Gutter Slope (%)	N/A
N/A	Gutter Lip Ht (in)	N/A	N/A	Gutter X Slope (%)	N/A
N/A	Painted X Walk1?	No	N/A	Painted X Walk2?	No
	X Walk 1 Direction	To NW		X Walk 2 Direction	To S
	X Walk 1 Width (in)	N/A		X Walk 2 Width (in)	N/A
	X Walk 1 Slope (%)	2.9		X Walk 2 Slope (%)	8.7
	X Walk 1 X Slope (%)	6.4		X Walk 2 X Slope (%)	4.7

N/A	Ramp inside XWalk1?	N/A	N/A	Ramp inside XWalk2?	N/A
	Road Slope (%)	5.4		Clear Space?	N/A
	Road X Slope (%)	3.8	N/A	Clear Space to XWalk (in)	N/A
N/A	Any Obstructions?	N/A	N/A	Storm Grate/Utility Hazard?	N/A
	Obstruction Type			Storm Grate/Utility Type	
		N/A			N/A
			Yes	Surface Condition? (G/P)	Good
			No	Curb Slope (%)	13.8

Remove & Replace Curb Ramp With Two New Directional Ramps or Equivalent.
