# Access Compliance Report

## Public Rights-of-Way

### (Curb Ramps)

Intersection ID: 23795	Main Street: DOWNS_RD	Cross Street: E WESTINGHOUSE BV	Location: SE
ADA ID: 2D49005965F2	Ramp Type: Perp	Initial Pass/Fail: Fail	Overall Compliance: No
Codes/Mitigation Info/Possible Solution		Field Measurements/Component Compliance	
Severity Score: 12.5

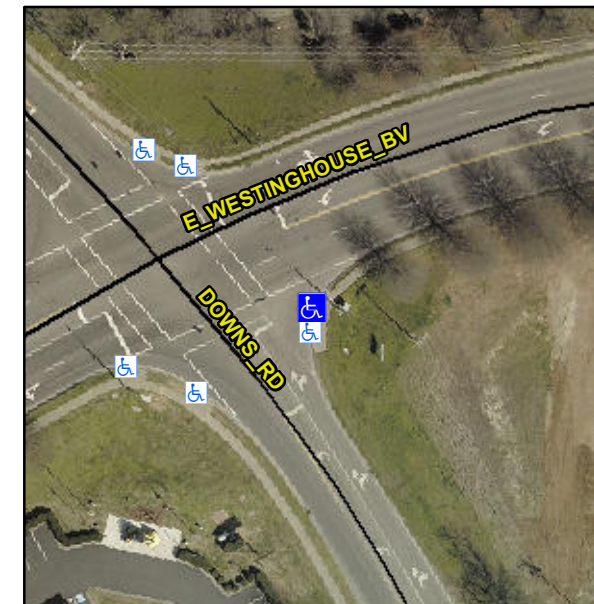
**Not Found, R304.2.2**

Compliance	Description	Data	Compliance	Description	Data
N/A	Ramp Length (in)	86.0	No	Ramp Slope (%)	9.0
Yes	Ramp Width (in)	48.0	Yes	Ramp XSlope (%)	0.3
N/A	Flare Type LT	N/A	N/A	Flare Type RT	N/A
N/A	Flare Slope LT (%)	N/A	N/A	Flare Slope RT (%)	N/A
N/A	Flare Traversable LT?	N/A	N/A	Flare Traversable RT?	N/A
N/A	Landing Length (in)	N/A	N/A	DWS Provided?	N/A
N/A	Landing Width (in)	N/A	N/A	DWS Contrast?	N/A
N/A	Landing Slope (%)	N/A	N/A	DWS Length (in)	N/A
N/A	Landing X Slope (%)	N/A	N/A	DWS Full Width?	N/A
N/A	Landing Curb? (Y/N)	N/A	N/A	DWS Offset (in)	N/A
N/A	Shared Landing?	N/A			
N/A	Gutter Ponding?	N/A	N/A	Gutter Slope (%)	N/A
N/A	Gutter Lip Ht (in)	N/A	N/A	Gutter X Slope (%)	N/A
N/A	Painted X Walk1?	Yes	N/A	Painted X Walk2?	N/A
	X Walk 1 Direction	To N		X Walk 2 Direction	N/A
N/A	X Walk 1 Width (in)	99.0	N/A	X Walk 2 Width (in)	N/A
	X Walk 1 Slope (%)	4.9		X Walk 2 Slope (%)	N/A
	X Walk 1 X Slope (%)	3.2		X Walk 2 X Slope (%)	N/A

N/A	Ramp inside XWalk1?	No	N/A	Ramp inside XWalk2?	N/A
	Road Slope (%)	N/A	N/A	Clear Space?	N/A
	Road X Slope (%)	N/A	N/A	Clear Space to XWalk (in)	N/A
N/A	Any Obstructions?	N/A	N/A	Storm Grate/Utility Hazard?	N/A
	Obstruction Type			Storm Grate/Utility Type	
		N/A			N/A
		Yes		Surface Condition? (G/P)	Good

Possible Solutions:

**Remove & Replace Entire Ramp.  
Restripe Crosswalk.**
