# Access Compliance Report

## Public Rights-of-Way

### (Curb Ramps)

Intersection ID: 10039789	Main Street: TOLLESON_AV	Cross Street: N/A	Location: NW
ADA ID: 2D4BC38BC231	Ramp Type: PerpDiag	Initial Pass/Fail: Fail	Overall Compliance: No
Codes/Mitigation Info/Possible Solution		Field Measurements/Component Compliance	
Severity Score: 13.75

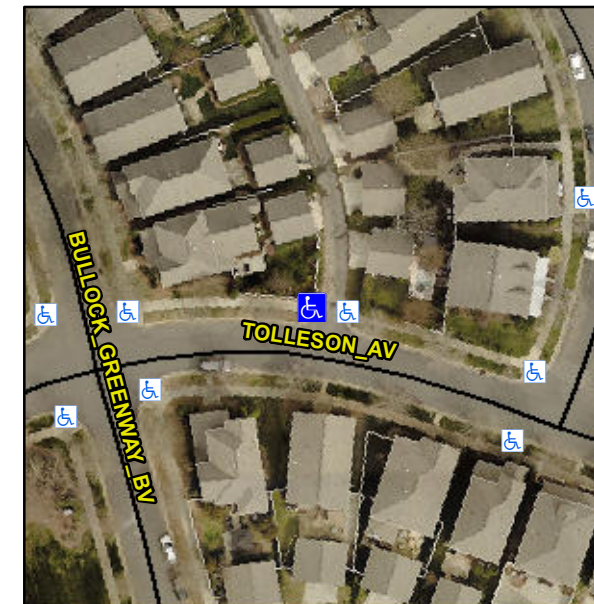
**Not Found, R304.2.2, R304.5.3**

Compliance	Description	Data	Compliance	Description	Data
N/A	Ramp Length (in)	106.0	No	Ramp Slope (%)	8.7
Yes	Ramp Width (in)	70.0	No	Ramp XSlope (%)	2.7
N/A	Flare Type LT	N/A	N/A	Flare Type RT	N/A
N/A	Flare Slope LT (%)	N/A	N/A	Flare Slope RT (%)	N/A
N/A	Flare Traversable LT?	N/A	N/A	Flare Traversable RT?	N/A
N/A	Landing Length (in)	N/A	N/A	DWS Provided?	N/A
N/A	Landing Width (in)	N/A	N/A	DWS Contrast?	N/A
N/A	Landing Slope (%)	N/A	N/A	DWS Length (in)	N/A
N/A	Landing X Slope (%)	N/A	N/A	DWS Full Width?	N/A
N/A	Landing Curb? (Y/N)	N/A	N/A	DWS Offset (in)	N/A
N/A	Shared Landing?	N/A			
N/A	Gutter Ponding?	N/A	N/A	Gutter Slope (%)	N/A
N/A	Gutter Lip Ht (in)	N/A	N/A	Gutter X Slope (%)	N/A
N/A	Painted X Walk1?	No	N/A	Painted X Walk2?	No
	X Walk 1 Direction	To S		X Walk 2 Direction	To E
N/A	X Walk 1 Width (in)	N/A	N/A	X Walk 2 Width (in)	N/A
	X Walk 1 Slope (%)	3.2		X Walk 2 Slope (%)	2.1
	X Walk 1 X Slope (%)	2.1		X Walk 2 X Slope (%)	1.9

N/A	Ramp inside XWalk1?	N/A	N/A	Ramp inside XWalk2?	N/A
	Road Slope (%)	2.3	N/A	Clear Space?	N/A
	Road X Slope (%)	2.4	N/A	Clear Space to XWalk (in)	N/A
N/A	Any Obstructions?	N/A	N/A	Storm Grate/Utility Hazard?	N/A
	Obstruction Type			Storm Grate/Utility Type	
		N/A			N/A
			Yes	Surface Condition? (G/P)	Good

Possible Solutions:

**Remove & Replace Curb Ramp With Two New Directional Ramps or Equivalent.**
