Access Compliance Report

Public Rights-of-Way

(Curb Ramps)

Intersection ID: 52999	Main Street: VICTORIA_BROOK_LN	Cross Street: GRANT_MARTIN_DR	Location: SW
ADA ID: 2D4CF6A953AE	Ramp Type: Perp	Initial Pass/Fail: Fail	Overall Compliance: No
			Severity Score: 8.75
Codes/Mitigation Info/Possible Solution		Field Measurements/Component Compliance

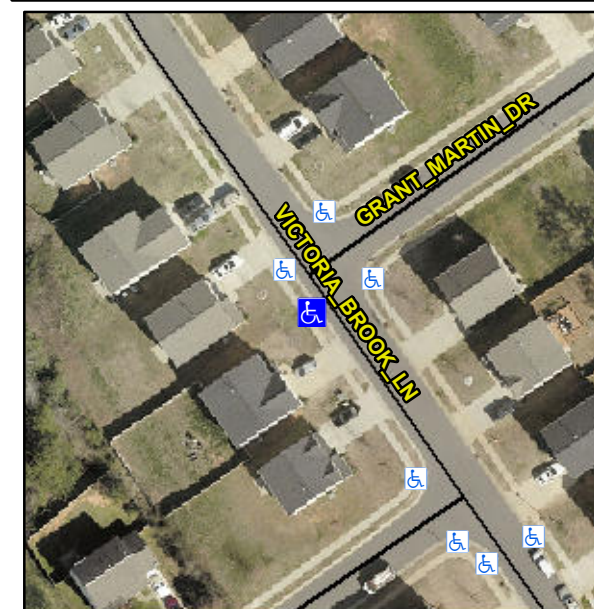
Not Found, R304.5.1

Compliance	Description	Data	Compliance	Description	Data
N/A	Ramp Length (in)	47.0	Yes	Ramp Slope (%)	6.4
No	Ramp Width (in)	47.5	Yes	Ramp XSlope (%)	1.1
N/A	Flare Type LT	N/A	N/A	Flare Type RT	N/A
N/A	Flare Slope LT (%)	N/A	N/A	Flare Slope RT (%)	N/A
N/A	Flare Traversable LT?	N/A	N/A	Flare Traversable RT?	N/A
N/A	Landing Length (in)	N/A	N/A	DWS Provided?	N/A
N/A	Landing Width (in)	N/A	N/A	DWS Contrast?	N/A
N/A	Landing Slope (%)	N/A	N/A	DWS Length (in)	N/A
N/A	Landing X Slope (%)	N/A	N/A	DWS Full Width?	N/A
N/A	Landing Curb? (Y/N)	N/A	N/A	DWS Offset (in)	N/A
N/A	Shared Landing?	N/A			
N/A	Gutter Ponding?	N/A	N/A	Gutter Slope (%)	N/A
N/A	Gutter Lip Ht (in)	N/A	N/A	Gutter X Slope (%)	N/A
N/A	Painted X Walk1?	No	N/A	Painted X Walk2?	N/A
	X Walk 1 Direction	To E		X Walk 2 Direction	N/A
N/A	X Walk 1 Width (in)	N/A	N/A	X Walk 2 Width (in)	N/A
	X Walk 1 Slope (%)	3.4		X Walk 2 Slope (%)	N/A
	X Walk 1 X Slope (%)	2.0		X Walk 2 X Slope (%)	N/A

N/A	Ramp inside XWalk1?	N/A	N/A	Ramp inside XWalk2?	N/A
	Road Slope (%)	N/A	N/A	Clear Space?	N/A
	Road X Slope (%)	N/A	N/A	Clear Space to XWalk (in)	N/A
N/A	Any Obstructions?	N/A	N/A	Storm Grate/Utility Hazard?	N/A
	Obstruction Type			Storm Grate/Utility Type	
		N/A			N/A
			Yes	Surface Condition? (G/P)	Good

Possible Solutions:

Remove & Replace Entire Ramp.

Total Cost: \$ 1850.00
