# Access Compliance Report

## Public Rights-of-Way

### (Curb Ramps)

Intersection ID: 29142	Main Street: APPLEDALE_DR	Cross Street: BRIDGEVILLE_LN	Location: E
ADA ID: 2D4FB3E6B2B9	Ramp Type: BlendTrans1	Initial Pass/Fail: Fail	Overall Compliance: No
Severity Score: 8.75			
Codes/Mitigation Info/Possible Solution		Field Measurements/Component Compliance

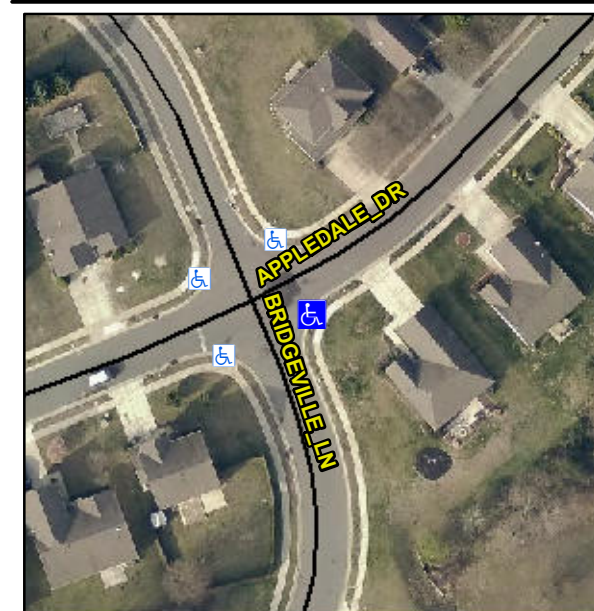
**Not Found, R304.5.1**

Compliance	Description	Data	Compliance	Description	Data
N/A	Ramp Length (in)	48.0	Yes	BlendTrans Slope (%)	0.2
No	Ramp Width (in)	47.0	Yes	BlendTrans XSlope (%)	2.0
N/A	Flare Type LT	N/A	N/A	Flare Type RT	N/A
N/A	Flare Slope LT (%)	N/A	N/A	Flare Slope RT (%)	N/A
N/A	Flare Traversable LT?	N/A	N/A	Flare Traversable RT?	N/A
N/A	Landing Length (in)	N/A	N/A	DWS Provided?	N/A
N/A	Landing Width (in)	N/A	N/A	DWS Contrast?	N/A
N/A	Landing Slope (%)	N/A	N/A	DWS Length (in)	N/A
N/A	Landing X Slope (%)	N/A	N/A	DWS Full Width?	N/A
N/A	Landing Curb? (Y/N)	N/A	N/A	DWS Offset (in)	N/A
N/A	Shared Landing?	N/A			
N/A	Gutter Ponding?	N/A	N/A	Gutter Slope (%)	N/A
N/A	Gutter Lip Ht (in)	N/A	N/A	Gutter X Slope (%)	N/A
N/A	Painted X Walk1?	No	N/A	Painted X Walk2?	No
	X Walk 1 Direction	To NW		X Walk 2 Direction	To SW
	X Walk 1 Width (in)	N/A		X Walk 2 Width (in)	N/A
	X Walk 1 Slope (%)	1.0		X Walk 2 Slope (%)	0.5
	X Walk 1 X Slope (%)	1.6		X Walk 2 X Slope (%)	0.7

N/A	Ramp inside XWalk1?	N/A	N/A	Ramp inside XWalk2?	N/A
	Road Slope (%)	0.8		Clear Space?	N/A
	Road X Slope (%)	0.6	N/A	Clear Space to XWalk (in)	N/A
N/A	Any Obstructions?	N/A	N/A	Storm Grate/Utility Hazard?	N/A
	Obstruction Type			Storm Grate/Utility Type	
		N/A			N/A
			Yes	Surface Condition? (G/P)	Good
			No	Curb Slope (%)	15.0

**Remove & Replace Curb Ramp With Two New Directional Ramps or Equivalent.**
