# Access Compliance Report

## Public Rights-of-Way

### (Curb Ramps)

Intersection ID: 6029	Main Street: PIMPERNEL_RD	Cross Street: ROSEMALLOW_RD	Location: NW
ADA ID: 2D50A1A25E72	Ramp Type: Perp	Initial Pass/Fail: Fail	Overall Compliance: No
		Severity Score: 25

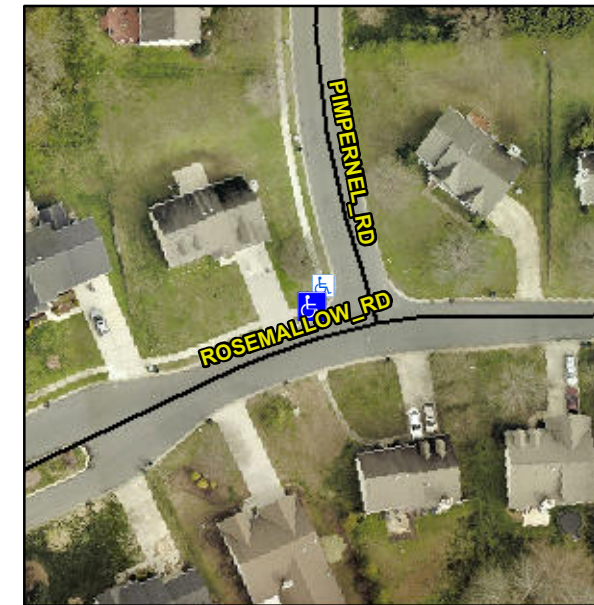
**Not Found, R304.5.3**

Compliance	Description	Data	Compliance	Description	Data
N/A	Ramp Length (in)	55.1	Yes	Ramp Slope (%)	5.3
Yes	Ramp Width (in)	80.0	No	Ramp XSlope (%)	11.2
N/A	Flare Type LT	N/A	N/A	Flare Type RT	N/A
N/A	Flare Slope LT (%)	N/A	N/A	Flare Slope RT (%)	N/A
N/A	Flare Traversable LT?	N/A	N/A	Flare Traversable RT?	N/A
N/A	Landing Length (in)	N/A	N/A	DWS Provided?	N/A
N/A	Landing Width (in)	N/A	N/A	DWS Contrast?	N/A
N/A	Landing Slope (%)	N/A	N/A	DWS Length (in)	N/A
N/A	Landing X Slope (%)	N/A	N/A	DWS Full Width?	N/A
N/A	Landing Curb? (Y/N)	N/A	N/A	DWS Offset (in)	N/A
N/A	Shared Landing?	N/A			
N/A	Gutter Ponding?	N/A	N/A	Gutter Slope (%)	N/A
N/A	Gutter Lip Ht (in)	2.0	N/A	Gutter X Slope (%)	N/A
N/A	Painted X Walk1?	No	N/A	Painted X Walk2?	N/A
	X Walk 1 Direction	To S		X Walk 2 Direction	N/A
N/A	X Walk 1 Width (in)	N/A	N/A	X Walk 2 Width (in)	N/A
	X Walk 1 Slope (%)	0.2		X Walk 2 Slope (%)	N/A
	X Walk 1 X Slope (%)	7.3		X Walk 2 X Slope (%)	N/A

N/A	Ramp inside XWalk1?	N/A	N/A	Ramp inside XWalk2?	N/A
	Road Slope (%)	N/A	N/A	Clear Space?	N/A
	Road X Slope (%)	N/A	N/A	Clear Space to XWalk (in)	N/A
N/A	Any Obstructions?	N/A	N/A	Storm Grate/Utility Hazard?	N/A
	Obstruction Type			Storm Grate/Utility Type	
		N/A			N/A
			Yes	Surface Condition? (G/P)	Good

**Remove & Replace Entire Ramp.**
