Access Compliance Report

Public Rights-of-Way

(Curb Ramps)

Intersection ID: 10029119	Main Street: JAMES_BLAKENEY_AV	Cross Street: N/A	Location: NE
ADA ID: 2D524F38DD35	Ramp Type: PerpDiag	Initial Pass/Fail: Fail	Overall Compliance: No
Severity Score: 13.75			
Codes/Mitigation Info/Possible Solution		Field Measurements/Component Compliance

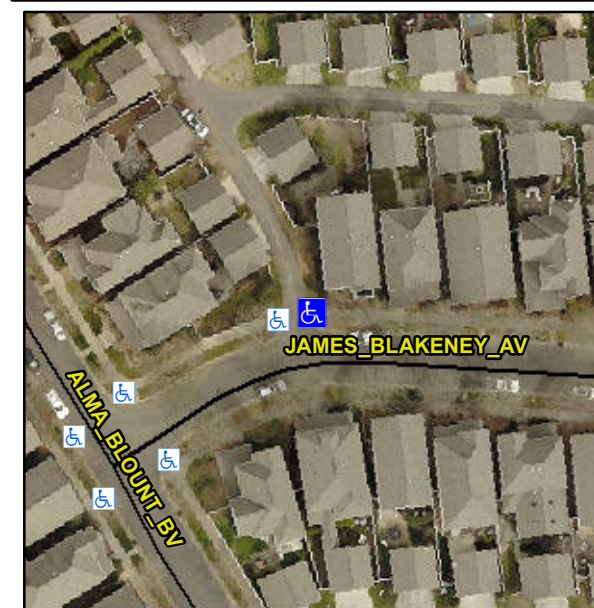
Compliance	Description	Data	Compliance	Description	Data
N/A	Ramp Length (in)	53.0	No	Ramp Slope (%)	10.6
Yes	Ramp Width (in)	53.0	No	Ramp XSlope (%)	2.7
N/A	Flare Type LT	N/A	N/A	Flare Type RT	N/A
N/A	Flare Slope LT (%)	N/A	N/A	Flare Slope RT (%)	N/A
N/A	Flare Traversable LT?	N/A	N/A	Flare Traversable RT?	N/A
N/A	Landing Length (in)	N/A	N/A	DWS Provided?	N/A
N/A	Landing Width (in)	N/A	N/A	DWS Contrast?	N/A
N/A	Landing Slope (%)	N/A	N/A	DWS Length (in)	N/A
N/A	Landing X Slope (%)	N/A	N/A	DWS Full Width?	N/A
N/A	Landing Curb? (Y/N)	N/A	N/A	DWS Offset (in)	N/A
N/A	Shared Landing?	N/A			
N/A	Gutter Ponding?	N/A	N/A	Gutter Slope (%)	N/A
N/A	Gutter Lip Ht (in)	N/A	N/A	Gutter X Slope (%)	N/A
N/A	Painted X Walk1?	No	N/A	Painted X Walk2?	No
	X Walk 1 Direction	To W		X Walk 2 Direction	To S
N/A	X Walk 1 Width (in)	N/A	N/A	X Walk 2 Width (in)	N/A
	X Walk 1 Slope (%)	0.4		X Walk 2 Slope (%)	1.4
	X Walk 1 X Slope (%)	1.3		X Walk 2 X Slope (%)	4.7

N/A	Ramp inside XWalk1?	N/A	N/A	Ramp inside XWalk2?	N/A
	Road Slope (%)	1.5	N/A	Clear Space?	N/A
	Road X Slope (%)	0.2	N/A	Clear Space to XWalk (in)	N/A
N/A	Any Obstructions?	N/A	N/A	Storm Grate/Utility Hazard?	N/A
	Obstruction Type			Storm Grate/Utility Type	
		N/A			N/A
		Yes		Surface Condition? (G/P)	Good

Remove & Replace Curb Ramp With Two New Directional Ramps or Equivalent.

R304.2.2, R304.5.3
