Access Compliance Report

Public Rights-of-Way

(Curb Ramps)

Intersection ID: 11727	Main Street: W_8TH_ST	Cross Street: N_POPLAR_ST	Location:	N
ADA ID: 2D5B2C82BB64	Ramp Type: PerpDiag	Initial Pass/Fail: Fail	Overall Compliance: No	Severity Score: 12.5

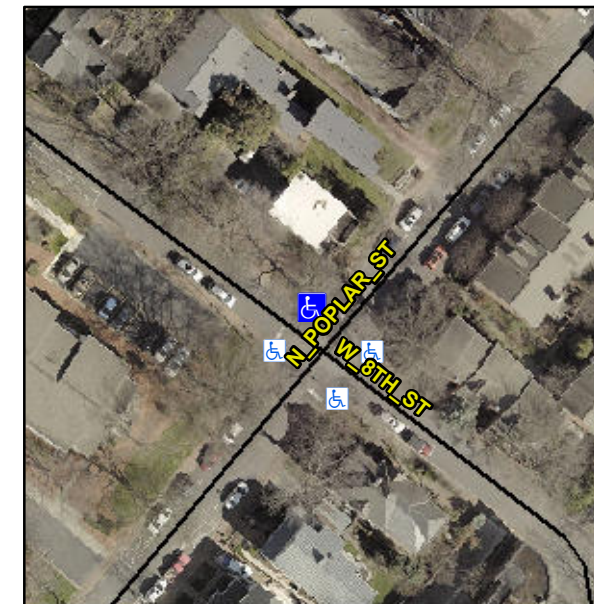
Not Found, R304.2.2

Compliance	Description	Data	Compliance	Description	Data
N/A	Ramp Length (in)	58.0	No	Ramp Slope (%)	10.2
Yes	Ramp Width (in)	66.0	Yes	Ramp XSlope (%)	1.4
N/A	Flare Type LT	N/A	N/A	Flare Type RT	N/A
N/A	Flare Slope LT (%)	N/A	N/A	Flare Slope RT (%)	N/A
N/A	Flare Traversable LT?	N/A	N/A	Flare Traversable RT?	N/A
N/A	Landing Length (in)	N/A	N/A	DWS Provided?	N/A
N/A	Landing Width (in)	N/A	N/A	DWS Contrast?	N/A
N/A	Landing Slope (%)	N/A	N/A	DWS Length (in)	N/A
N/A	Landing X Slope (%)	N/A	N/A	DWS Full Width?	N/A
N/A	Landing Curb? (Y/N)	N/A	N/A	DWS Offset (in)	N/A
N/A	Shared Landing?	N/A			
N/A	Gutter Ponding?	N/A	N/A	Gutter Slope (%)	N/A
N/A	Gutter Lip Ht (in)	N/A	N/A	Gutter X Slope (%)	N/A
N/A	Painted X Walk1?	No	N/A	Painted X Walk2?	No
	X Walk 1 Direction	To SW		X Walk 2 Direction	To SE
N/A	X Walk 1 Width (in)	N/A	N/A	X Walk 2 Width (in)	N/A
	X Walk 1 Slope (%)	6.7		X Walk 2 Slope (%)	10.4
	X Walk 1 X Slope (%)	1.9		X Walk 2 X Slope (%)	2.5

N/A	Ramp inside XWalk1?	N/A	N/A	Ramp inside XWalk2?	N/A
	Road Slope (%)	6.2	N/A	Clear Space?	N/A
	Road X Slope (%)	1.4	N/A	Clear Space to XWalk (in)	N/A
N/A	Any Obstructions?	N/A	N/A	Storm Grate/Utility Hazard?	N/A
	Obstruction Type			Storm Grate/Utility Type	
		N/A			N/A
			Yes	Surface Condition? (G/P)	Good

Remove & Replace Curb Ramp With Two New Directional Ramps or Equivalent.

Total Cost: \$ 3200.00
