Access Compliance Report Public Rights-of-Way (Curb Ramps)

Intersection ID: 10037250	Main Street: SARDIS_HALL_CT	Cross Street: N/A	Location: E
ADA ID: 2D67287E2EC1	Ramp Type: Perp	Initial Pass/Fail: Fail	Overall Compliance: No Severity Score: 21.25
Codes/Mitigation Info/Possible Solution		Field Measurements/Component Compliance

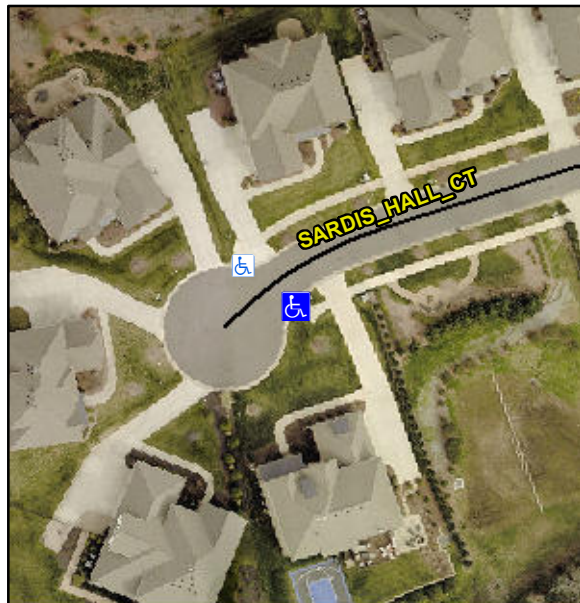
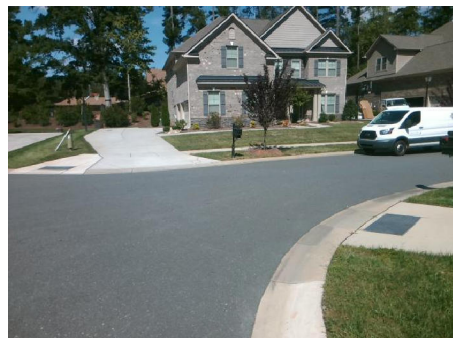
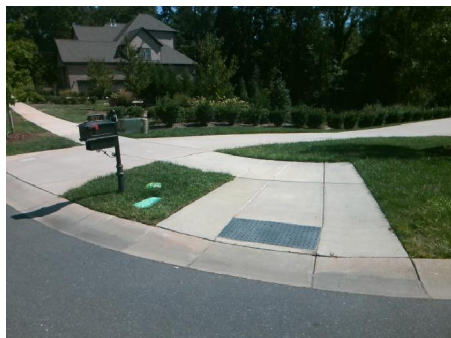
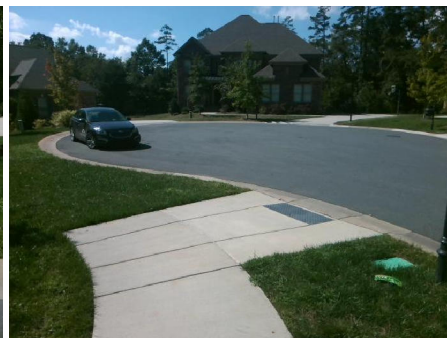
R304.5.1, R304.2.2

Compliance	Description	Data	Compliance	Description	Data
N/A	Ramp Length (in)	94.0	No	Ramp Slope (%)	8.6
No	Ramp Width (in)	37.0	Yes	Ramp XSlope (%)	0.3
N/A	Flare Type LT	N/A	N/A	Flare Type RT	N/A
N/A	Flare Slope LT (%)	N/A	N/A	Flare Slope RT (%)	N/A
N/A	Flare Traversable LT?	N/A	N/A	Flare Traversable RT?	N/A
N/A	Landing Length (in)	N/A	N/A	DWS Provided?	N/A
N/A	Landing Width (in)	N/A	N/A	DWS Contrast?	N/A
N/A	Landing Slope (%)	N/A	N/A	DWS Length (in)	N/A
N/A	Landing X Slope (%)	N/A	N/A	DWS Full Width?	N/A
N/A	Landing Curb? (Y/N)	N/A	N/A	DWS Offset (in)	N/A
N/A	Shared Landing?	N/A			
N/A	Gutter Ponding?	N/A	N/A	Gutter Slope (%)	N/A
N/A	Gutter Lip Ht (in)	N/A	N/A	Gutter X Slope (%)	N/A
N/A	Painted X Walk1?	No	N/A	Painted X Walk2?	N/A
	X Walk 1 Direction	To NW		X Walk 2 Direction	N/A
N/A	X Walk 1 Width (in)	N/A	N/A	X Walk 2 Width (in)	N/A
	X Walk 1 Slope (%)	1.2		X Walk 2 Slope (%)	N/A
	X Walk 1 X Slope (%)	0.5		X Walk 2 X Slope (%)	N/A

N/A	Ramp inside XWalk1?	N/A	N/A	Ramp inside XWalk2?	N/A
	Road Slope (%)	N/A	N/A	Clear Space?	N/A
	Road X Slope (%)	N/A	N/A	Clear Space to XWalk (in)	N/A
N/A	Any Obstructions?	N/A	N/A	Storm Grate/Utility Hazard?	N/A
	Obstruction Type			Storm Grate/Utility Type	
		N/A			N/A
			Yes	Surface Condition? (G/P)	Good

Remove & Replace Entire Ramp.

Total Cost: \$ 1850.00
